HERITAGE REPAIRS REPORT  
FOR THE REDEVELOPMENT  
OF MERCHANT PLACE AND  
CORY'S BUILDING  
CARDIFF, CF10 5AL

21.22-EDS-XX-ZZ-RP-A-XX-1001  
Heritage Repairs Report  
Revision 02

Applicant:  
Dukes Education

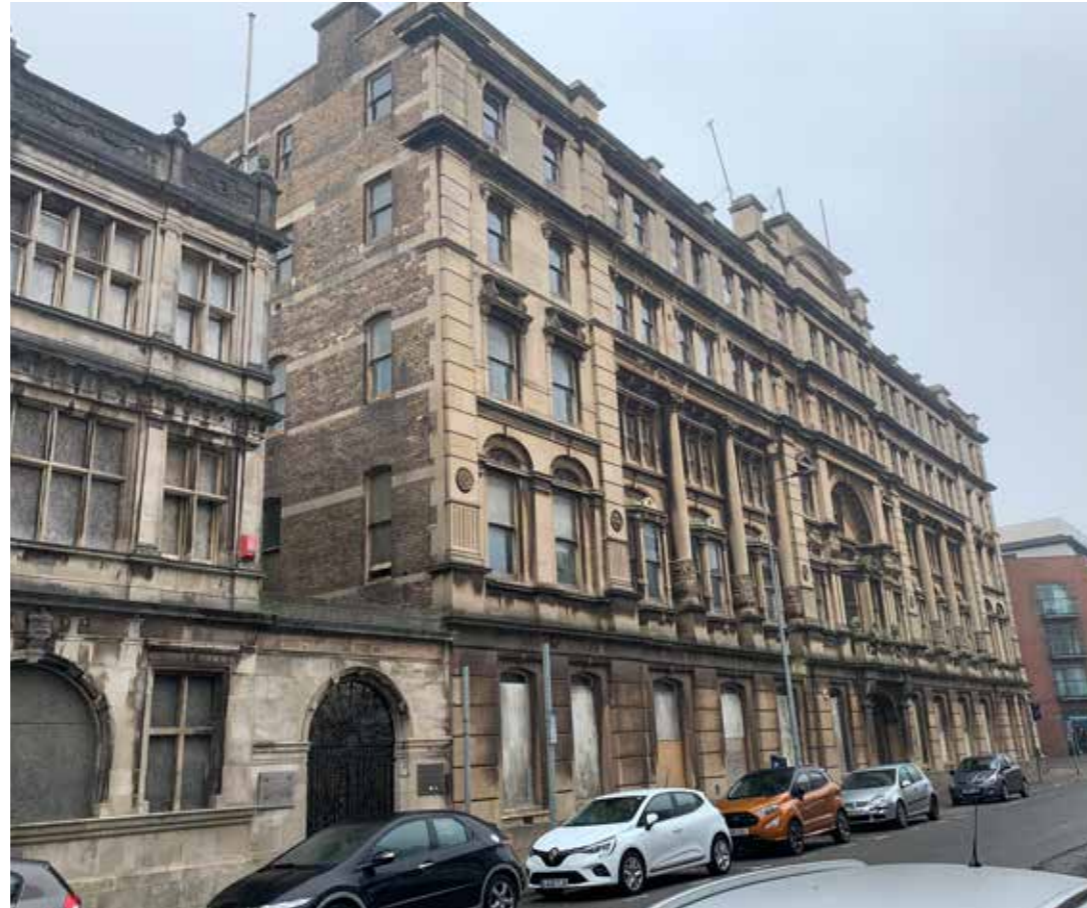
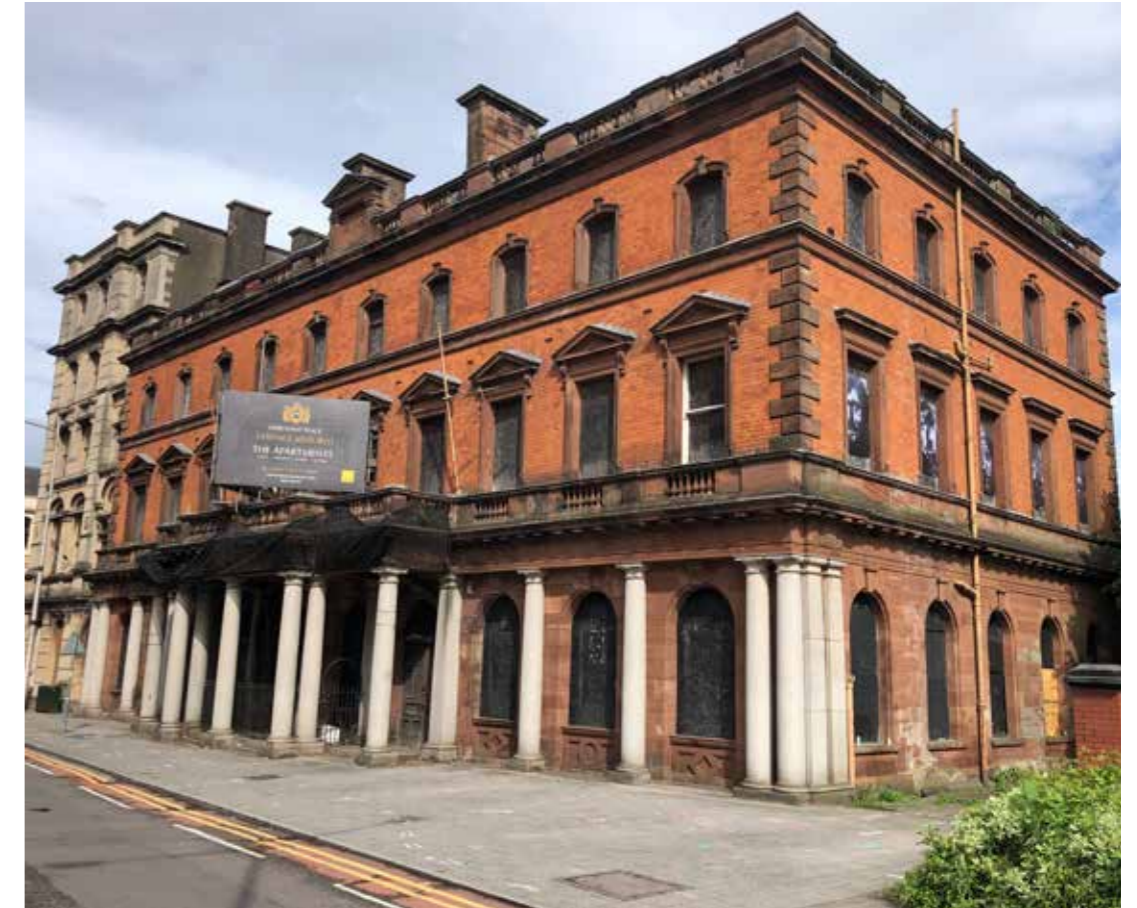
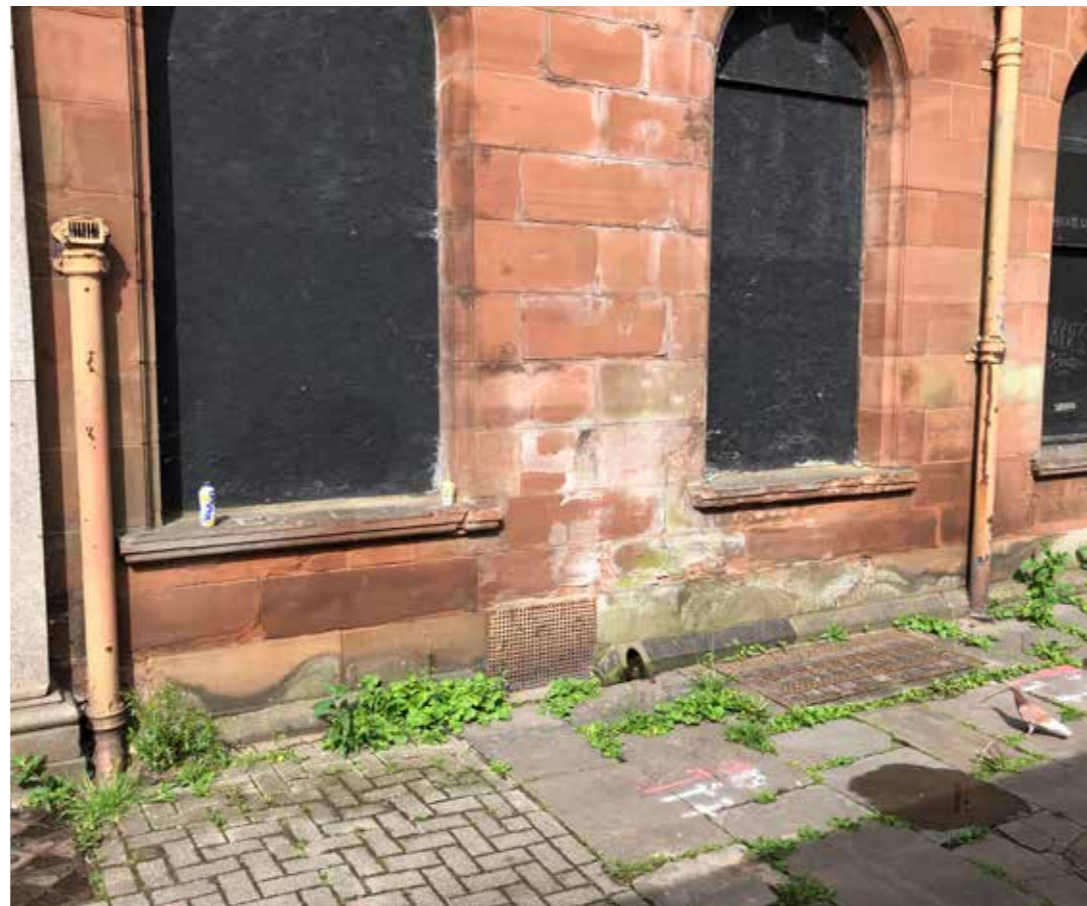
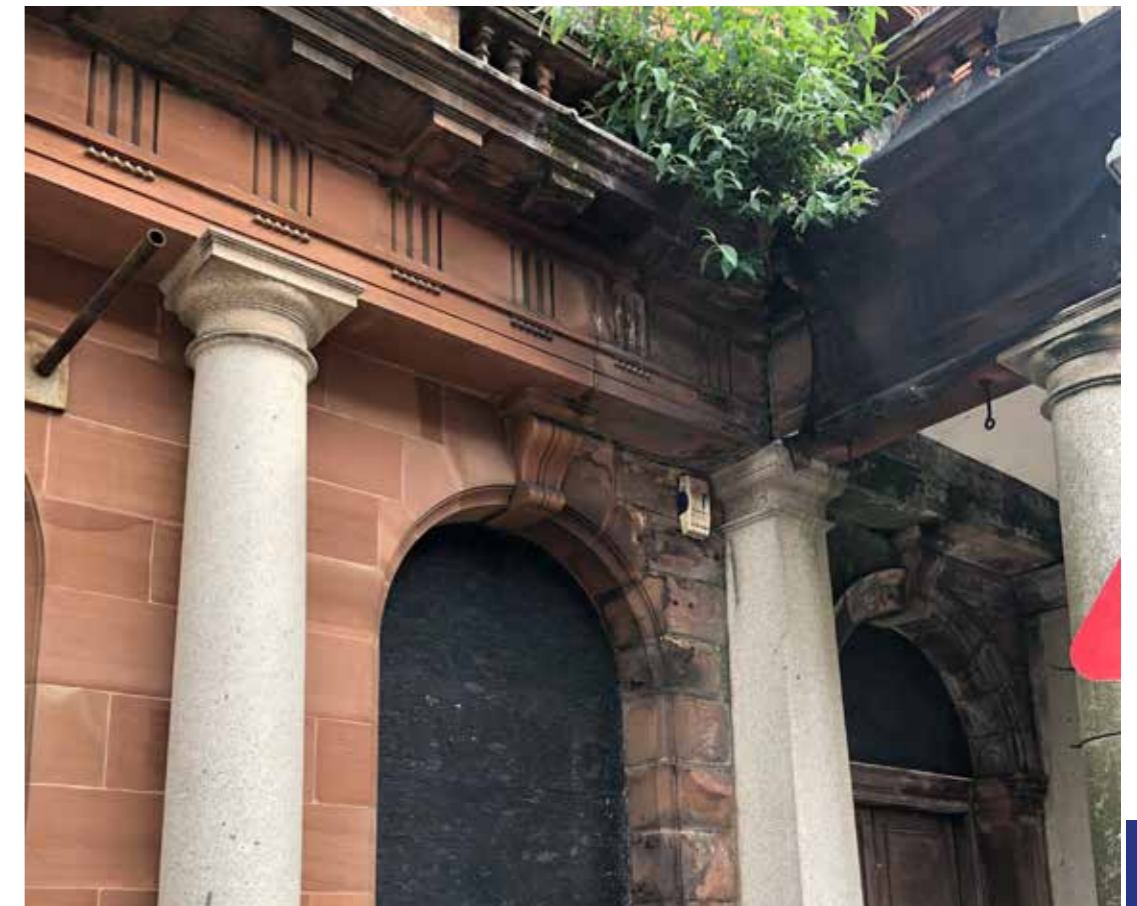
Initial analysis shows that the masonry condition of Cory's Building is fairly good, however, Merchant Place is not in such good condition. Examples of this can be seen in the lower pictures.

A survey of the ground floor indicates that a series of regrouting, and colour match skim to the damaged stone is required. Access has been limited to the ground floor and so a full condition survey would not be able to be undertaken without scaffold access. A similar restoration approach of the ground floor would be undertaken on the upper floors.

Once all the repairs have been completed, a post cleaning masonry sealant would be applied to protect the newly restored building.
