Cory's Building
and Merchants
House

**Bute Street
Cardiff
CF10 5BP**

An **Ecological Survey**
Report By:

Client	Dukes Education
Project Name	Cory's Building and Merchants House, Bute Street, Cardiff CF10 5BP
Report Title	An Ecological Survey Report
File Reference	BAT1917 Report (2022)

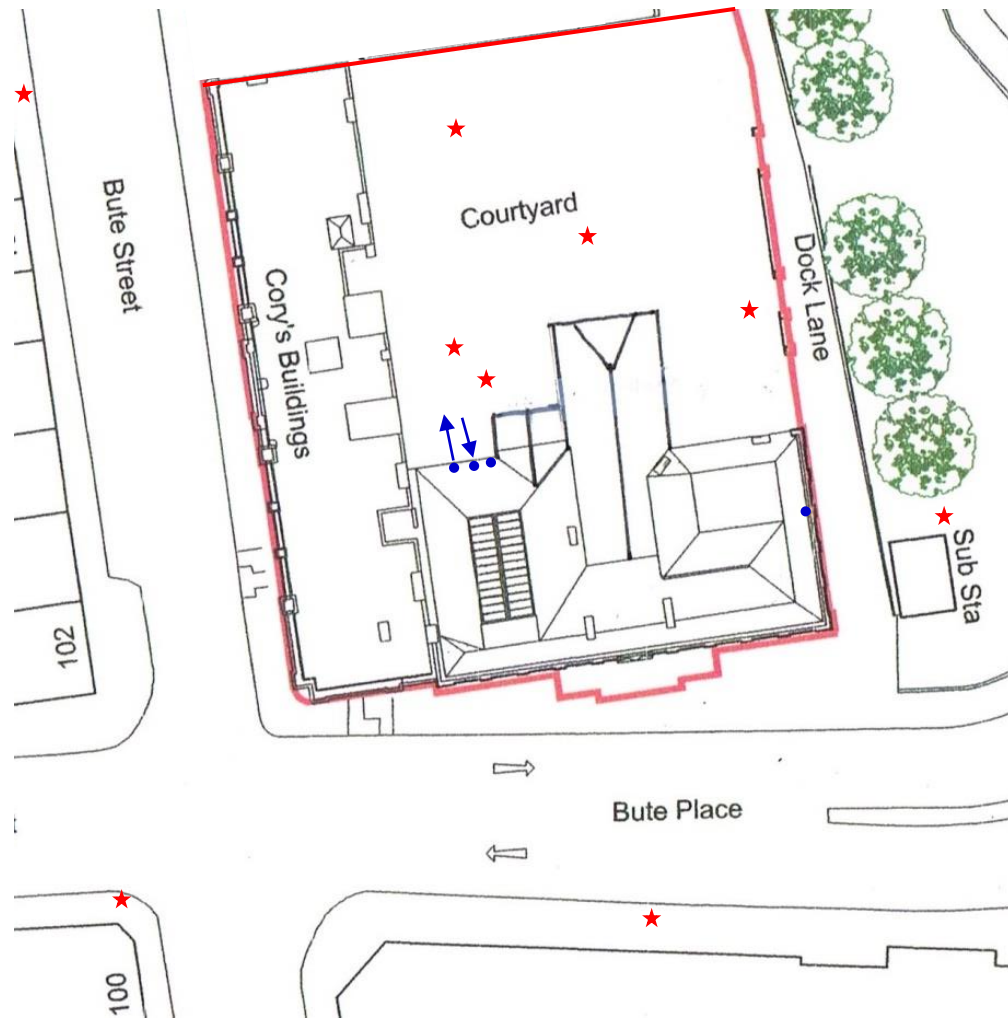
Figure 5: Site Layout showing evidence of bat activity and position of observers

- 8.9 The internal parts of Merchants House noted a light scattering of bat droppings in the first floor rooms. Small concentrations of fresh and old droppings are located on the window sills and around the edges of the plywood boards that obscure the four first floor windows at the north-west corner of the building. At the western-most window, no droppings were found, the next window to the east 10 fresh pipistrelle droppings were noted on the sill with an additional *circa* 30 droppings on the floor by the window. At the next window moving westwards, only old droppings were noted with *circa* 15 on the sill and 10 on the floor. At the fourth and easternmost window, c.100 old pipistrelle droppings were present on the sill and 50 on the floor. In the first floor rooms on the eastern side of Merchants House, a small number of old bat droppings (c.20) were found around boarded window casements. Additional droppings were noted in cobwebs and on walls. No bat droppings were found in the roof void of Merchants House.

Actual and potential bat access points:	Gaps around the edge of the roof, damaged and missing roof tiles, damaged timber features on the roof, gaps around window casements and around the edge of boarded windows, gaps between window frames and the casement, gaps in stone and brickwork, gaps at grills into the basements
Actual and potential bat roosting sites:	Gaps between window frames and the window casement, gaps with the roof coverings and the sarking lining, in cracks in walls and around the edge of the roof structure
Species and number recorded:	<u>8th June 2022</u> Common pipistrelle (2) entered at NW area first floor boarded window of Merchants House Common pipistrelle (1) emerged at NW area first floor boarded window of Merchants House <u>20th June 2022</u> Common pipistrelle (1) entered at NW area first floor boarded window of Merchants House Common pipistrelle (1) emerged at NW area first floor boarded window of Merchants House

Droppings recorded:	<u>Merchants House:</u> First floor – rear and east casement window sills – small quantity of fresh and old pipistrelle droppings First floor – light scattering on floor of old pipistrelle droppings

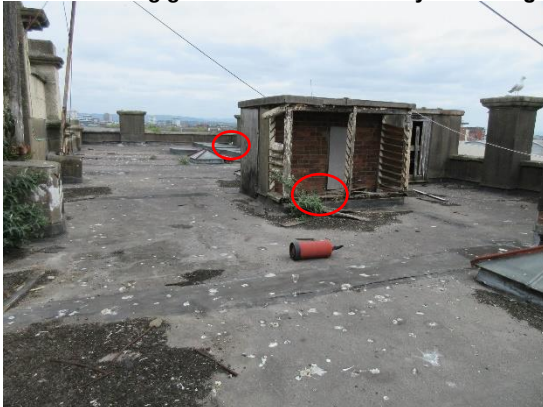
- 8.4 Nesting birds were considered during the PEA/PRA and three active herring gull nests, with eggs, were noted on the roof of Cory's Building. A view from this elevated location was used to examine the roof of Merchants House and no active bird nests were observed in late April 2022. Several ledges and features of high potential for nesting gulls were noted and there is a high likelihood that additional nests were established after the date of the PEA/PRA visit. Gull species will exploit the roofs of building if shelter and any features create a secure platform for their nests.

Plate 3: Herring gull nests on roof of Cory's Building

- 10.11 As birds will seek to establish nest sites on the roofs of the two buildings, the same recommendations for the modifications to the two buildings are made in relation to breeding birds. A small section on the north elevation of Merchants House will be removed to facilitate the link to the proposed new structure. If nests are present or become established, then they must be retained and protected. A cordon must be established for a safe working zone a suitable distance from the nest, and not until the chicks have fledged can the nest be destroyed. Where active nests are identified, precautions as described above must be followed so that the birds can breed successfully and eggs and chicks are not lost. Only when a nest is no longer active can it be removed. A suitably qualified and experienced ecologist must be retained on a watching brief during the period of vegetation clearance and building modifications to make a site visit and provide appropriate advice if any wildlife species are encountered.

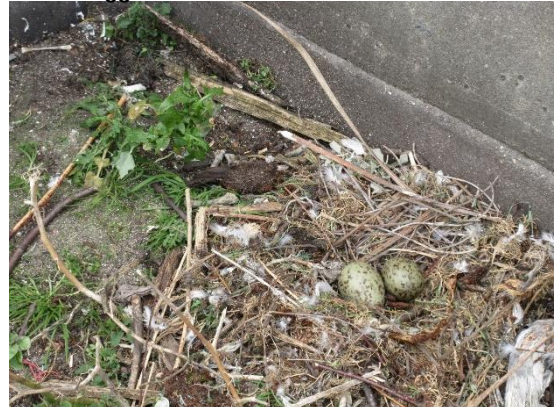
Plate 4: Eggs in one of the nests

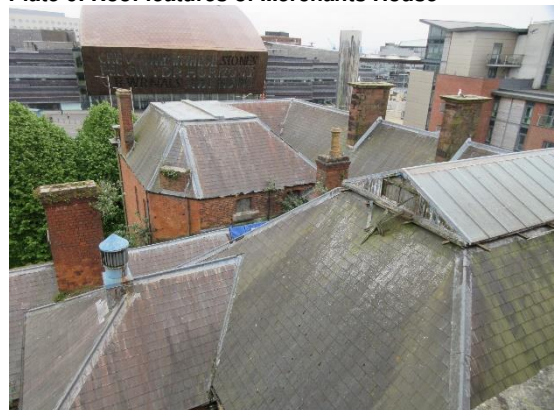
Plate 6: Roof features of Merchants House

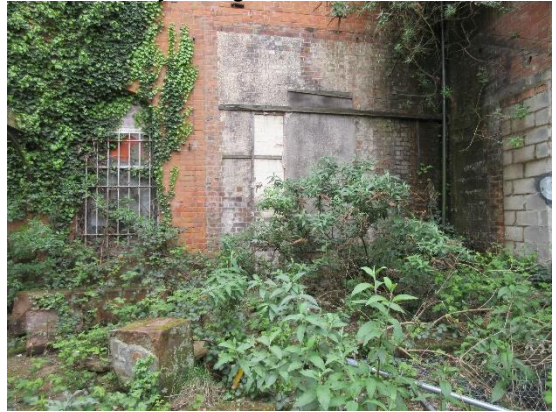
Plate 10: Courtyard vegetation

- 10.10 All nesting birds, their nests, chicks and eggs are protected by Part 1 of the Wildlife and Countryside Act 1981 (as amended). Clearance of the shrub vegetation in the courtyard must consider the potential presence of active nests. Vegetation removal work is recommended to take place during the autumn/winter months of late August to February inclusive in order to avoid the bird nesting season of the species noted at the site. If this is not possible, then the vegetation must be carefully checked by an appropriately qualified ecologist immediately ahead of any removal.

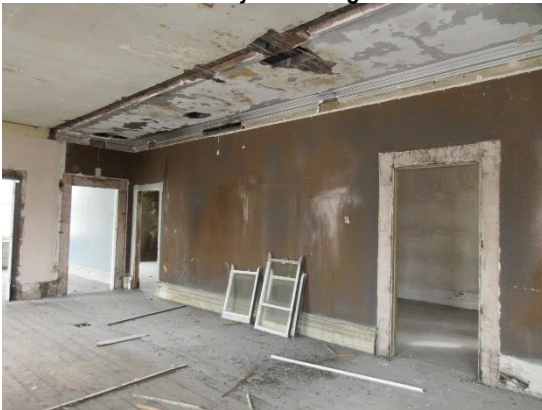
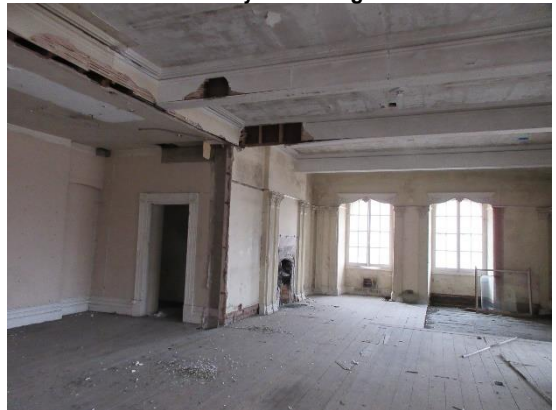
- 8.8 An internal inspection of Cory's Building found no evidence for the presence of bats, but nesting feral pigeons were found in at least four places, along with numerous (7) dead examples. No obvious cause of death was apparent, but some may have become trapped inside the building. Access for the pigeons is possible on several levels via gaps around boarded windows.

Plate 11: Interior of Cory's Building

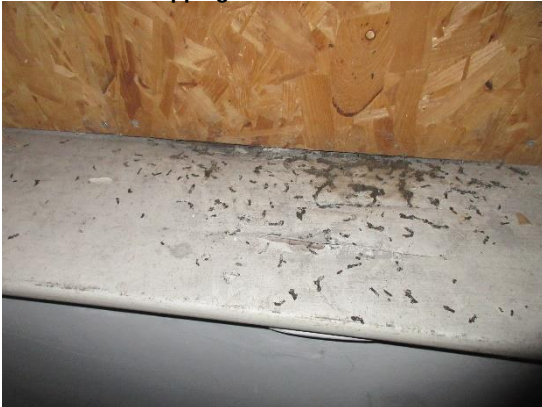
Plate 13: Bat droppings at windows in Merchants House

- 10.4 For crevice roosting pipistrelle bats, an appropriate scheme of mitigation is put forward with two enclosed bat boxes incorporated into the upper level walls of Cory's Building on the east facing elevation at the southern end. Regular foraging activity was noted in this area. Also, bat mitigation features will be provided on Merchants House which aim to replicate the slots currently used in window casement locations. Two enclosed bat boxes are to be installed at high level on the east facing elevation close to the connective tree line of Lloyd George Avenue. Also, a feature to mimic an enclosed bat box will be created within the roof covering on the east facing roof area to provide bat access to the narrow space between the slate roof covering and the timber sarking lining. This is the sort of slot feature that crevice roosting pipistrelle bats make use of. Access to the internal space is provided by creating a small opening from the lower edge of the lead ridge capping and forming an upward angled tunnel effect of dimensions 18mm x 25mm. Artificial lighting issues in this part of the site must be designed to avoid light spill from elevated parts of the proposed new building. This location for the bat mitigation is also close to the connectivity of the tree line on Lloyd George Avenue, to the east of Merchants House. Bat friendly materials must be used where mitigation features are present. New timbers and any remedial timber treatment products must be checked to ensure that chemicals toxic to bats are not used. These locations will be subject to the approval of the local planning authority due to the listed status of the buildings. They must be annotated to the design plans so as to be fully integrated into the project plan.

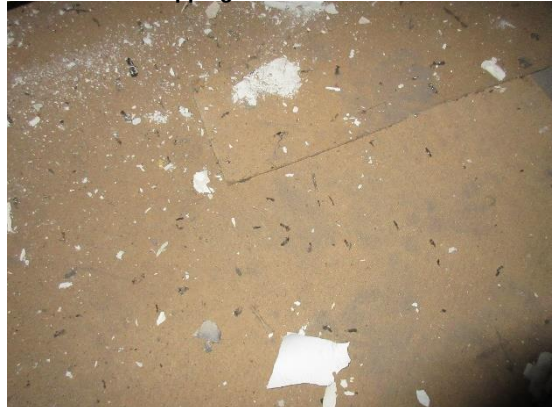
Plate 14: Bat droppings on floor in front of windows

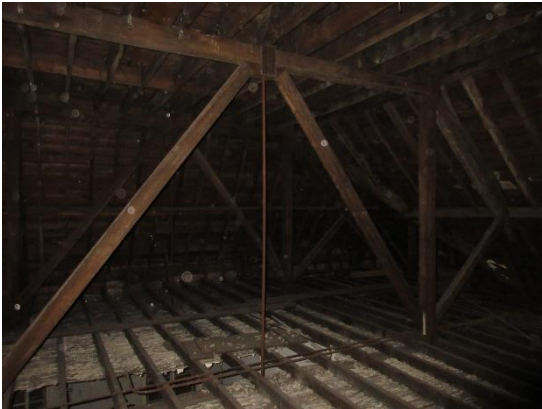
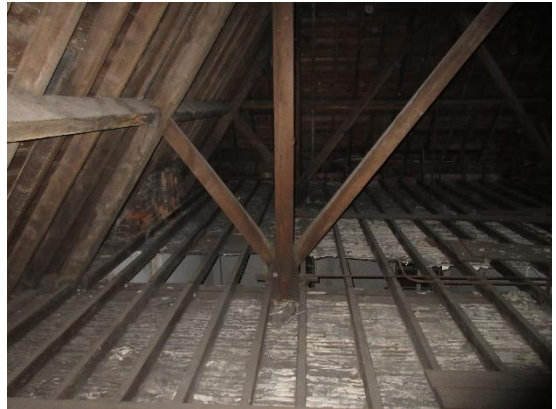
Plate 15: Roof void in Merchants House

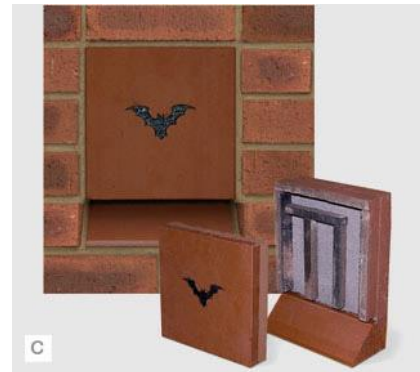
Figure 8: Two examples of enclosed bat box types: Schwegler bat tube and Ibstock box type c

The Bat Tube 1FR requires no maintenance or cleaning, the sloping entrance area allows droppings to simply fall out of the chamber. The 1FR mimics the cavities that species such as the pipistrelles favour and the wooden back panel helps maintain the optimum climatic conditions and also provides surface on which the bats can cling. The depth of this box (125mm) makes it ideal for use in 9" solid walls or where the outer skin of a property is of stone. The box can also be recessed into the wall and rendered over, just leaving the access section clear.

Size: 470x200x125mm

Weight: 9.5kg
