Plot 5, Cardiff Bay

Archaeological Desk-based Assessment

Date: August 2022
By: Rachel Morgan and Elspeth St John-Brooks
Client: Expedite
Project Code: RR0513
GGAT ref: CAR0722

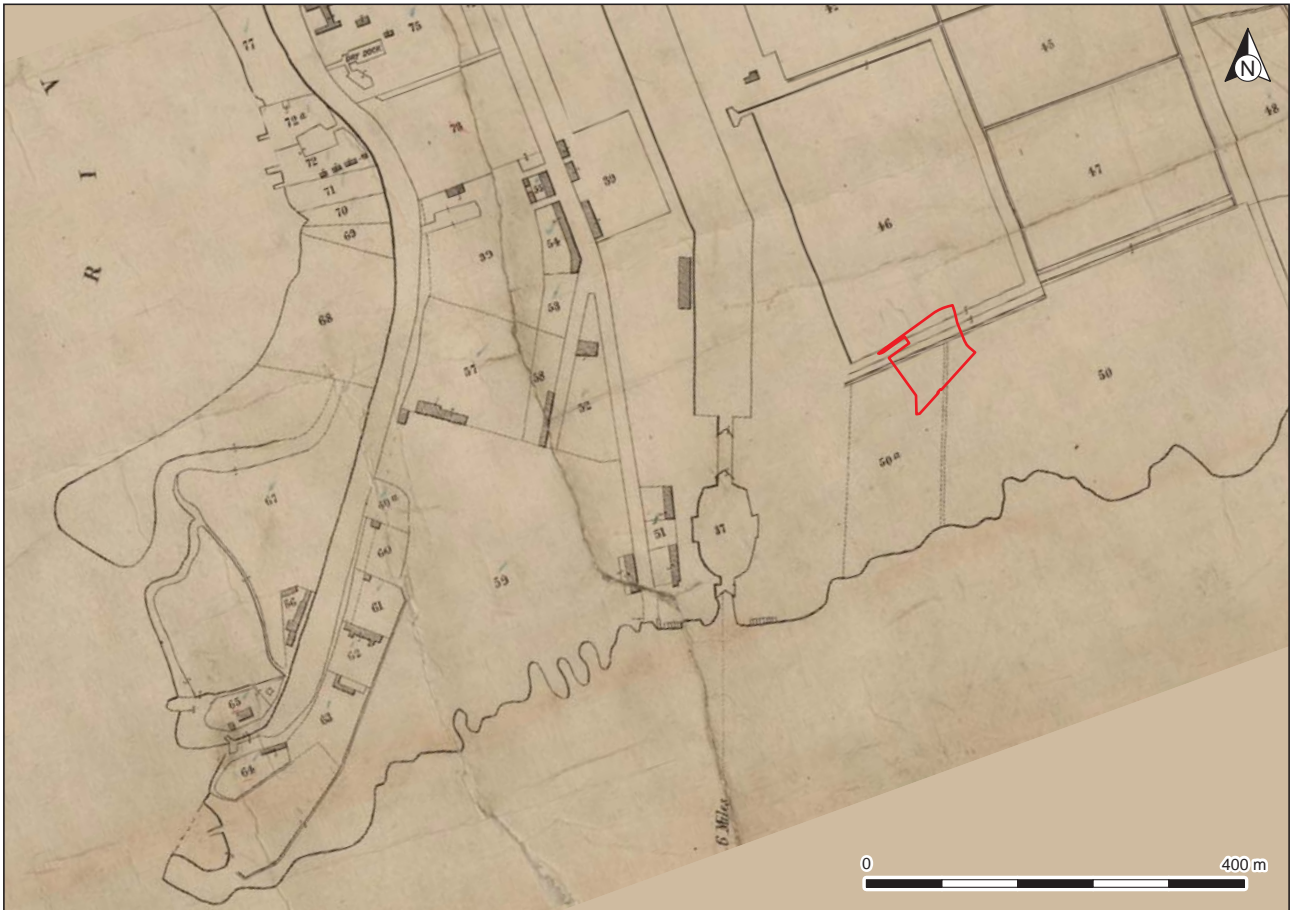
Figure 4 - Tithe map (1845) of the parish of Saint Mary, Cardiff, in the county of Glamorgan.

6.11.1 The Tithe map covering the parish of Saint Mary, Cardiff, in the county of Glamorgan, dated 1845) shows that the area has changed drastically in layout since this survey was completed. The Site is located at the junction of three plots: a small section of plot 46 to the north; a section of plot 50 to the east; and plot 50a covers most of the Site to the south and east. Plot 46 is labelled as Reservoir Banks and Ditches, plot 50 and 50a were pastureland during this period. The area

is not built up at this stage although development of the docks and associated structures including the Bute West Dock and Bute West Dock Basin can be seen to the west of Site (Fig. 4).

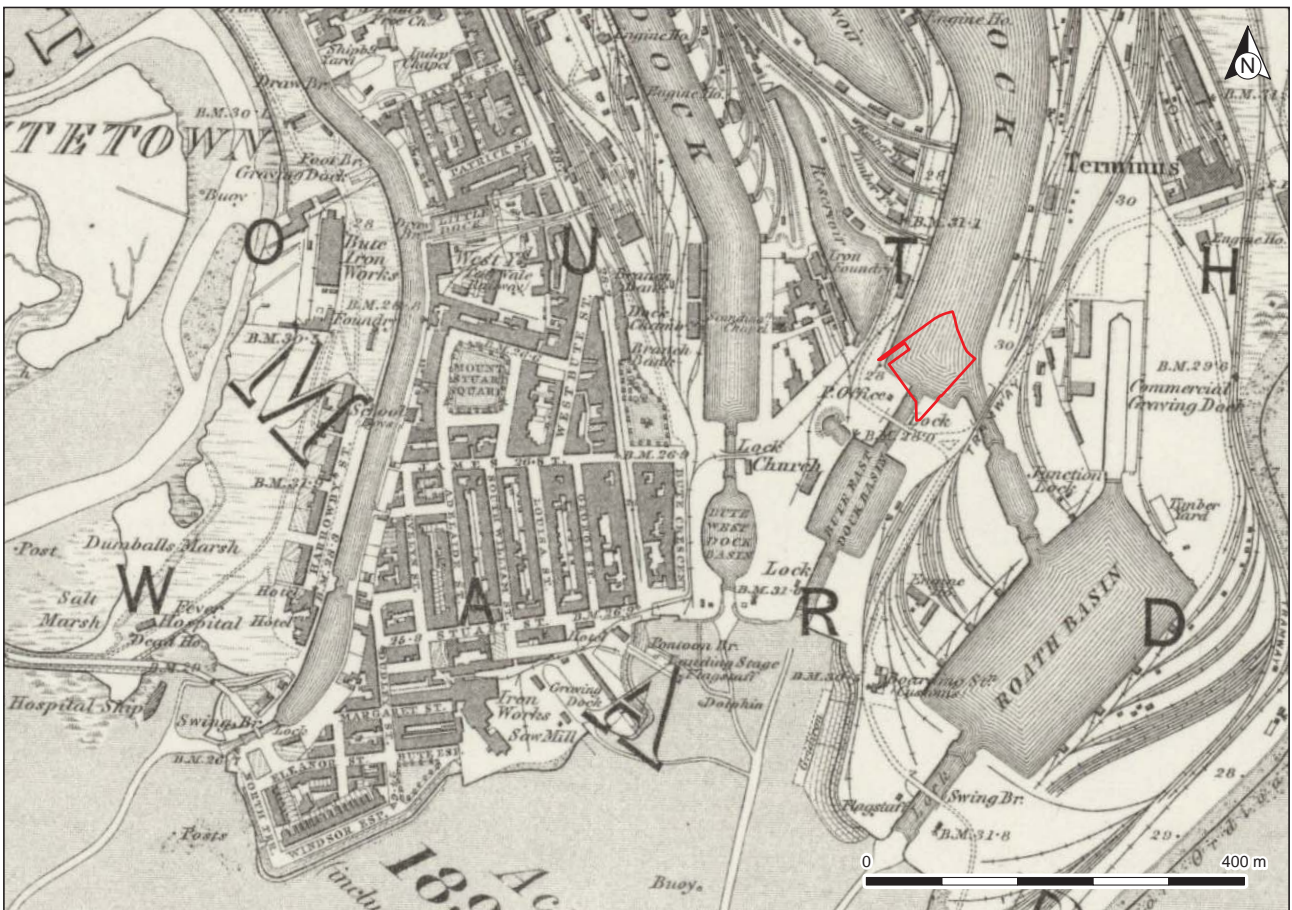
Figure 5 - Glamorgan Sheet XLVII (Surveyed 1878-1879, Published 1885).

- 6.11.2 The Ordnance Survey 6-inch map of Glamorgan Sheet XLVII, surveyed from 1878-9 and published in 1885 shows Plot 5 Site overlies the south end of the Bute East Dock where it joins the lock into the Bute East Dock Basin. A small section of trackway is present in the northwest corner of Site and the lock gates appear to lie just within the Site boundary in the southwest corner (Fig. 5).

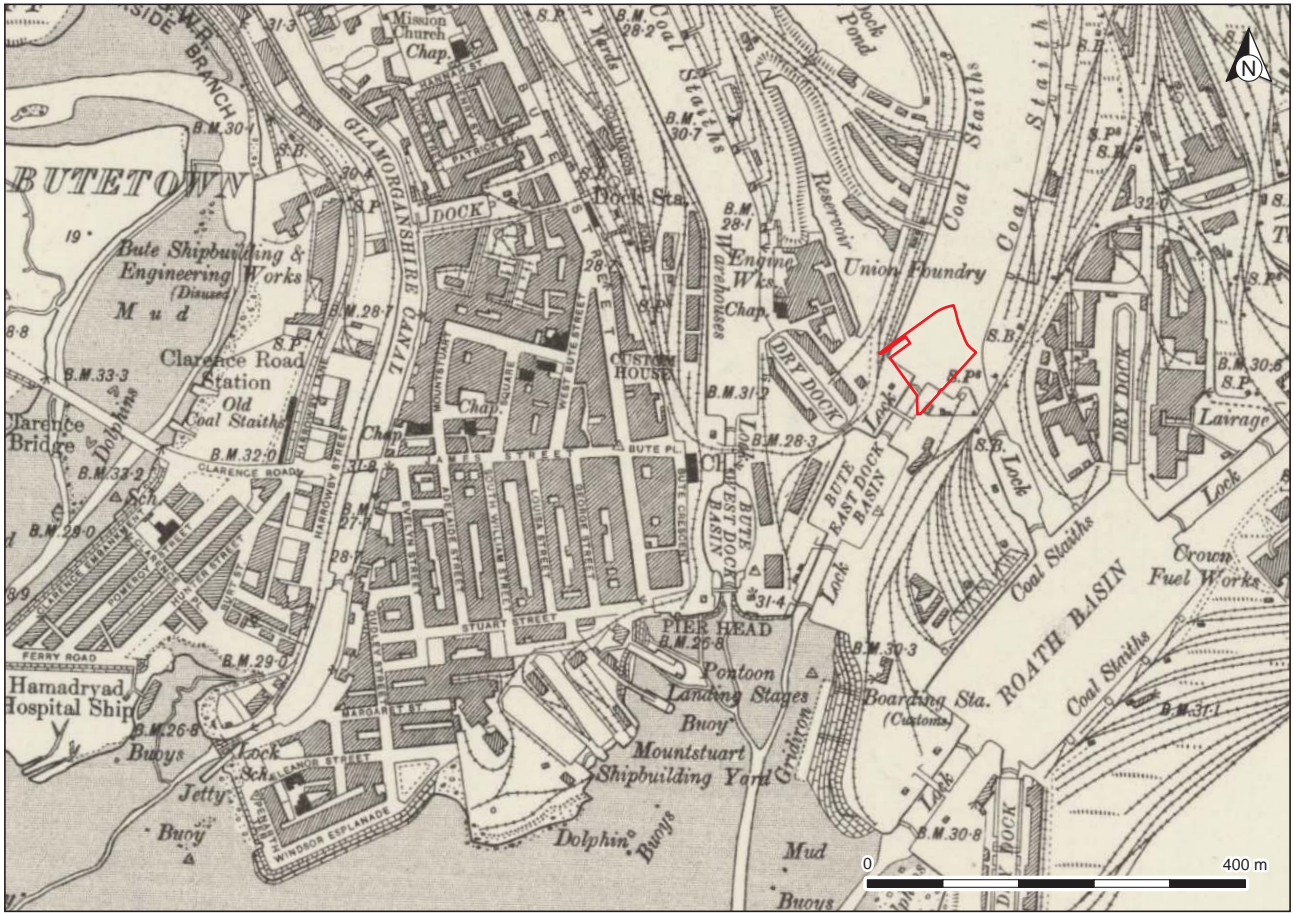
Figure 6 - Glamorgan Sheet XLVII.NE (Revised 1898-1899, Published 1901).

- 6.11.3 The Ordnance Survey 6-inch map of Glamorgan Sheet XLVII.NE, revised in 1898-9 and published in 1901 shows that Plot 5 Site is unchanged (Fig. 6).

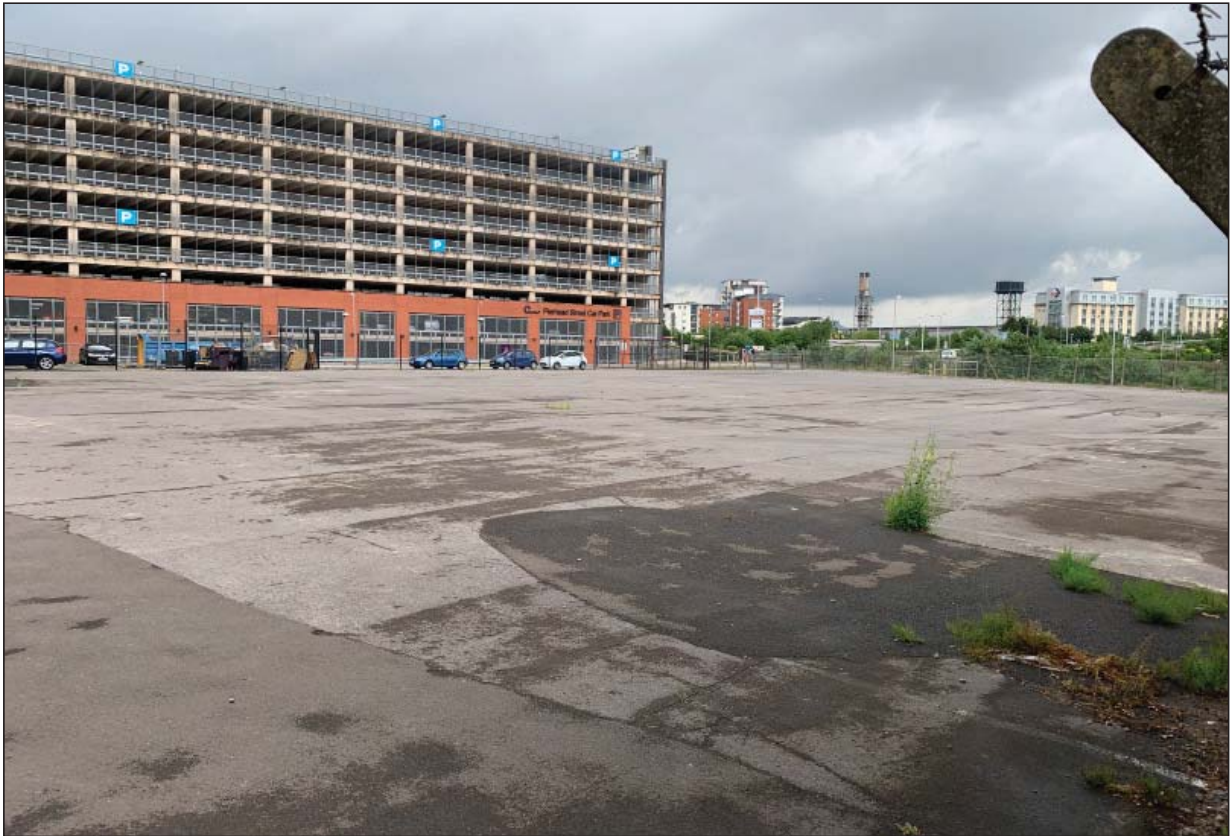
Plate 1 - Overview of Site, looking northeast

6.14.1 The site visit was conducted on 6 June 2022 on a bright sunny day and visibility was good. The Site consists of an area of asphalt surrounded by wire fencing on the northwest side of Pierhead St., partially used as a car park (Q-Park) (Fig. 1; Plates 1-8). The northwest corner of the area is used as a car park, but the plot is otherwise unoccupied. The Premier Inn flanks the southwestern boundary of the Site (Plates 2, 3, 5 and 8) and Pierhead Street Car Park building and access road is located just beyond the north-western boundary (Plates 1, 3, and 4). The Site is surrounded by modern buildings constructed in the late 20th and early 21st centuries.
