HERITAGE REPAIRS REPORT  
FOR THE REDEVELOPMENT  
OF MERCHANT PLACE AND  
CORY'S BUILDING  
CARDIFF, CF10 5AL

21.22-EDS-XX-ZZ-RP-A-XX-1001  
Heritage Repairs Report  
Revision 02

Applicant:  
Dukes Education

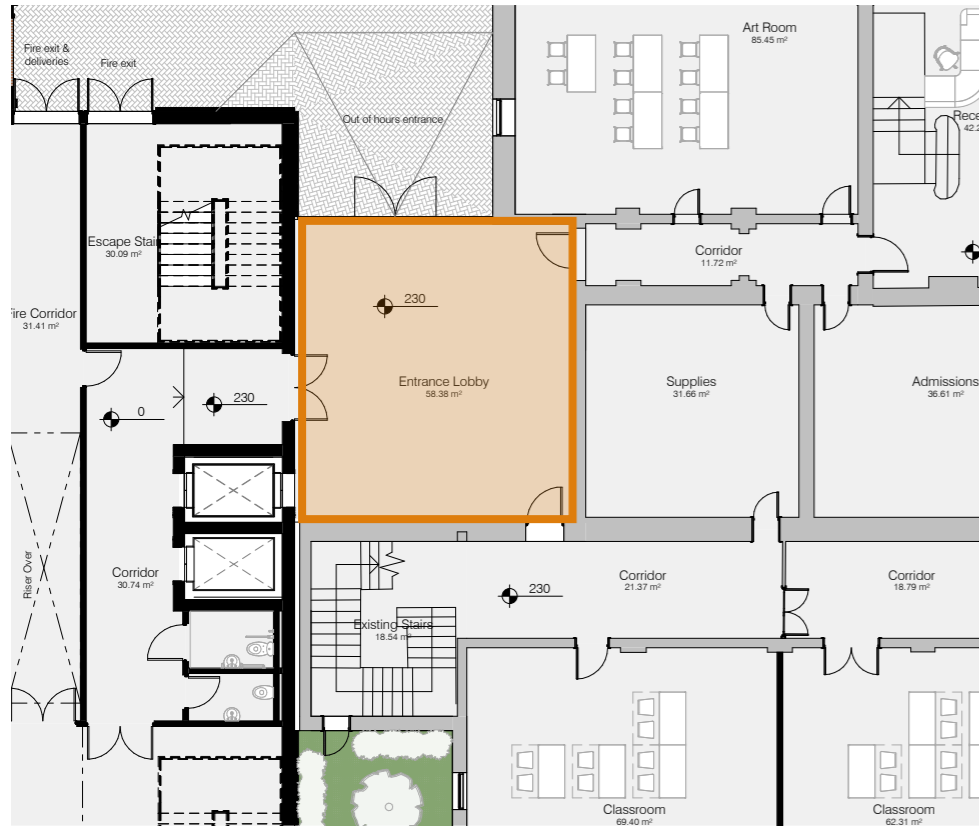
# M0.10

There is currently no access into this room therefore the extent of works cannot be determined.

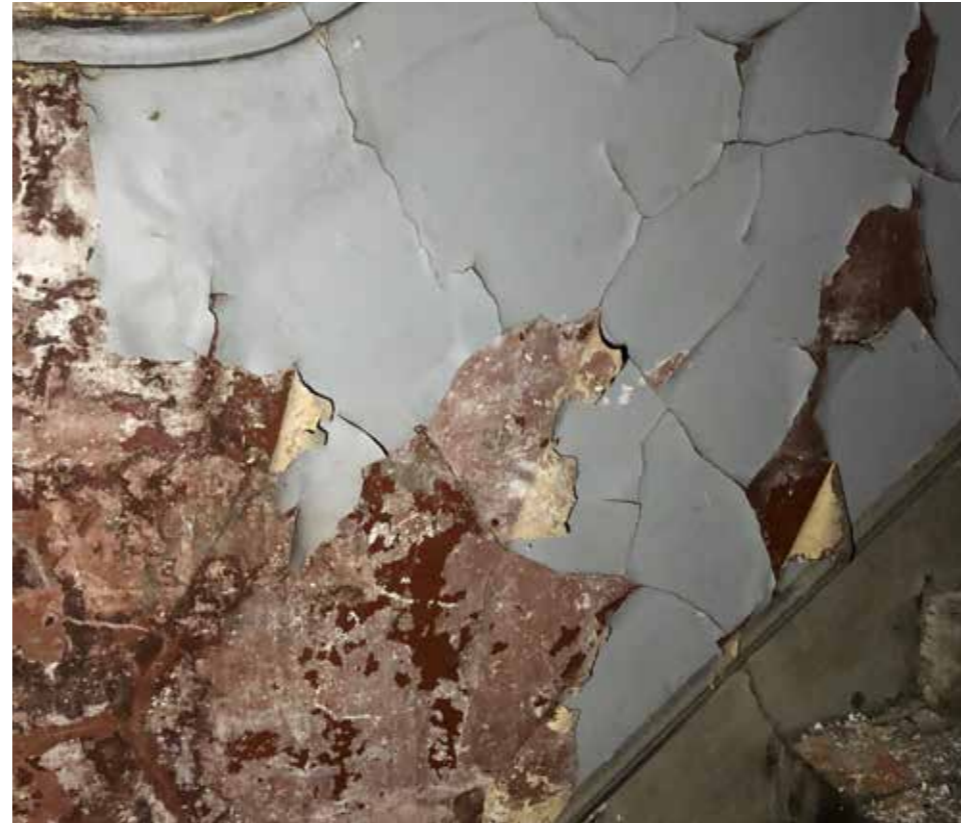
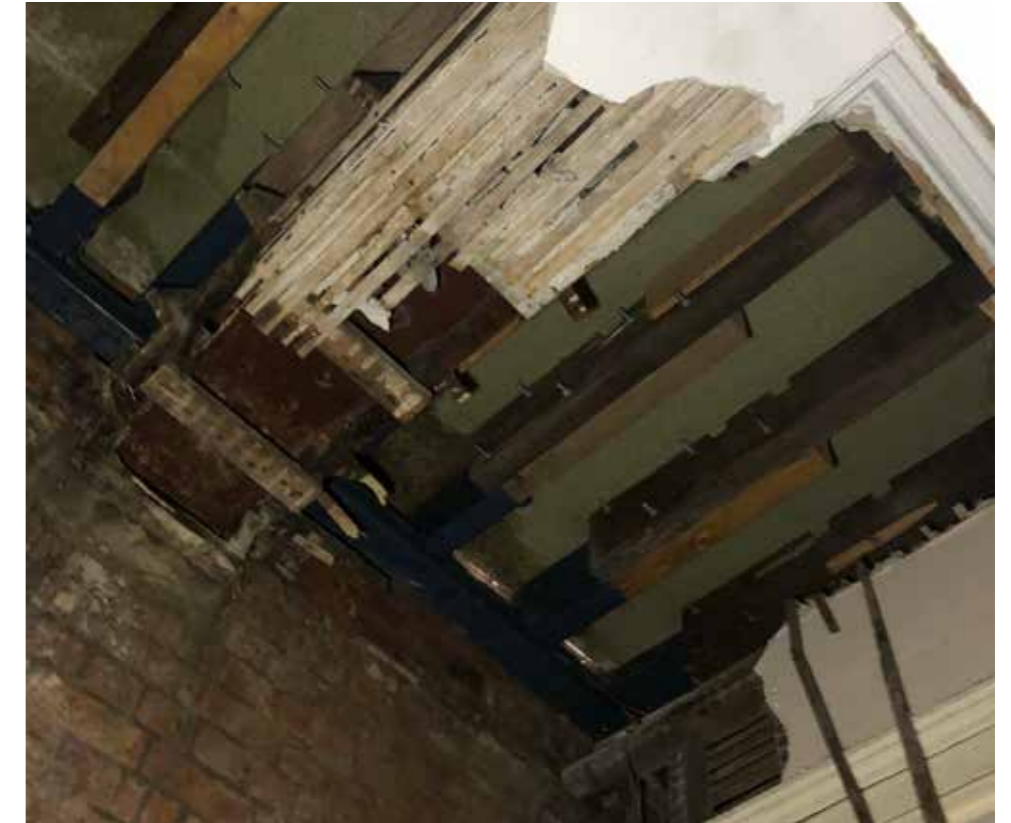
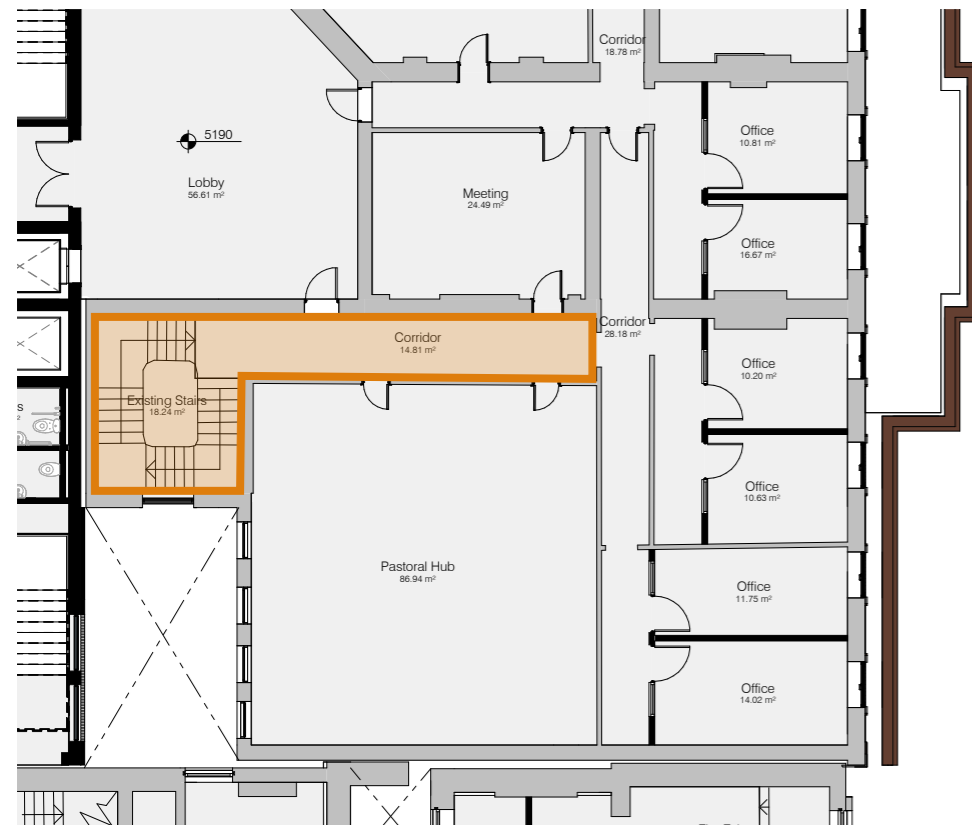
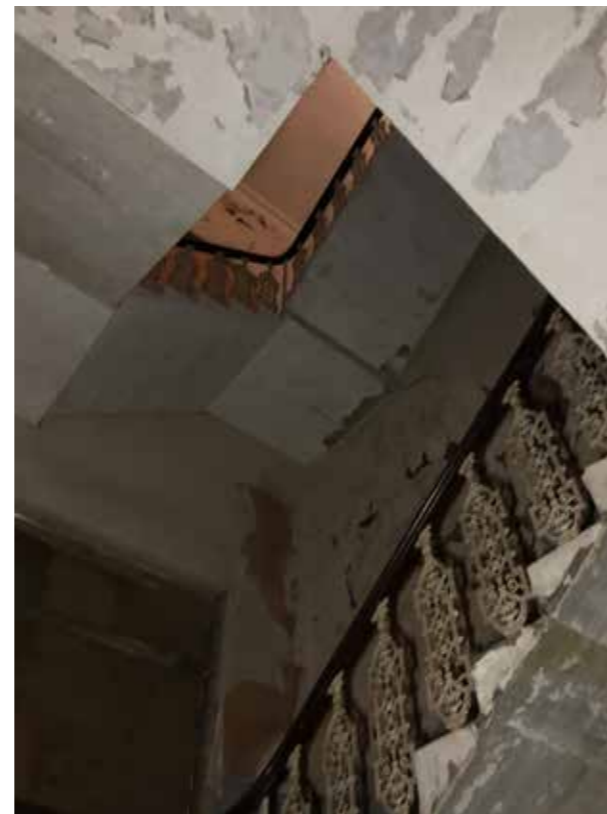
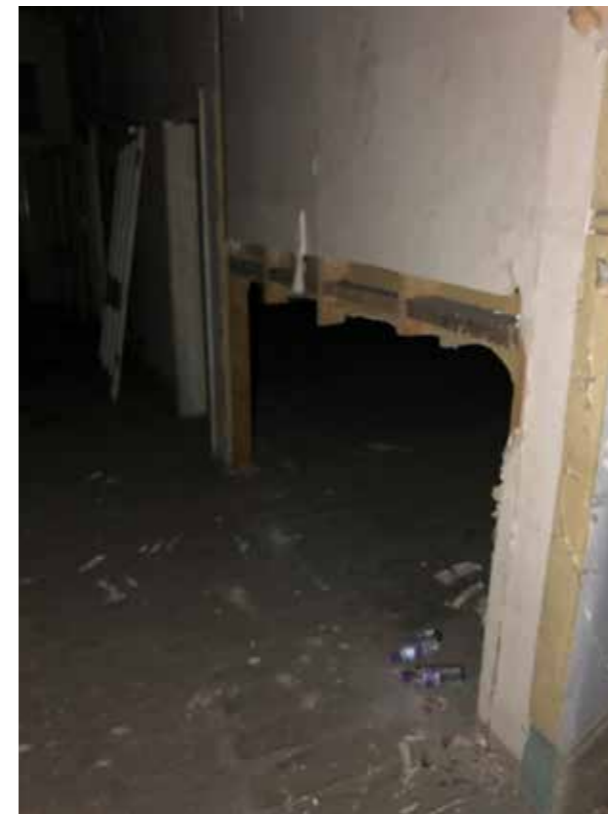
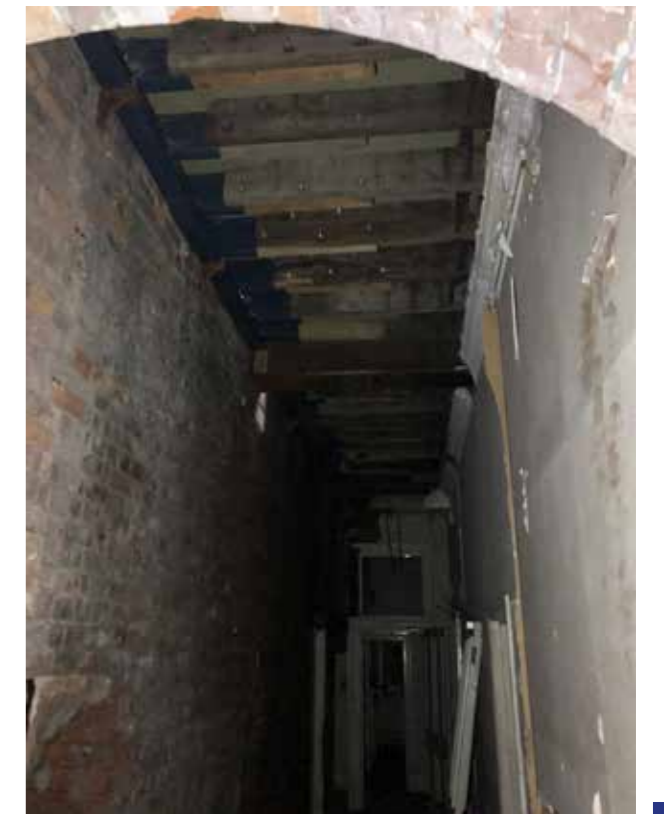
# M1.14

The majority of this room will be demolished. The remaining walls will be made good and painted.

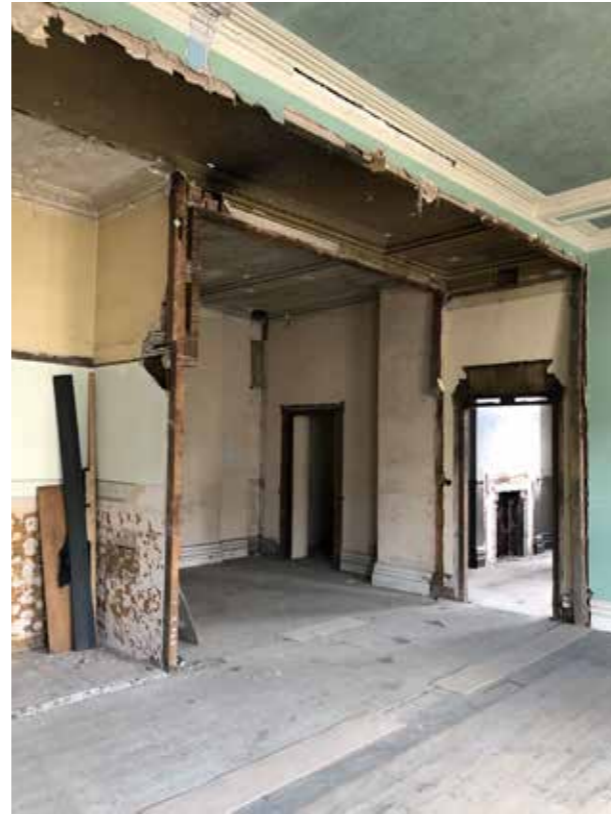
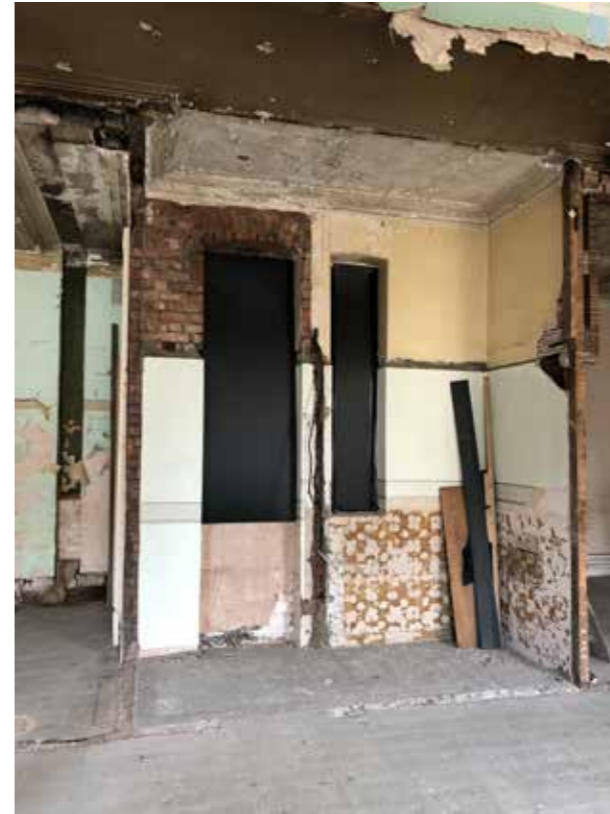
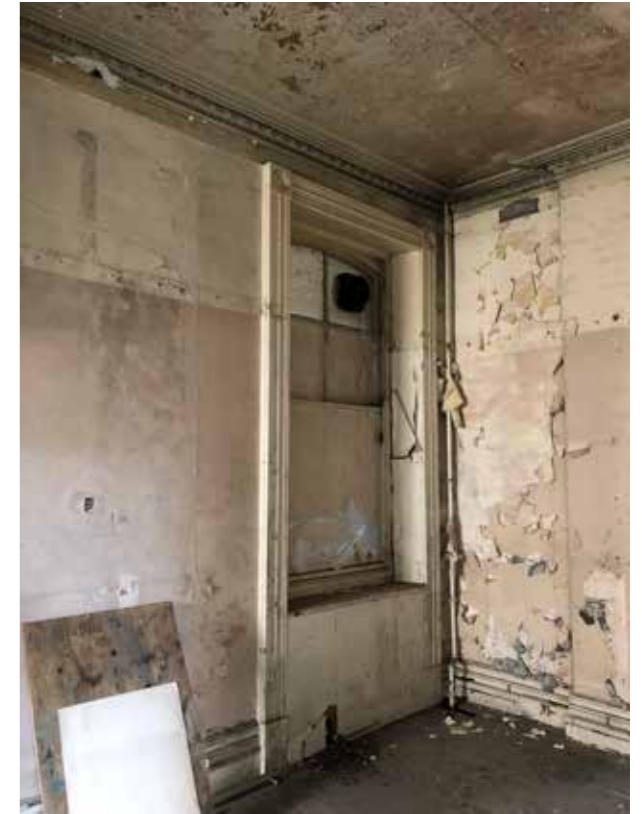
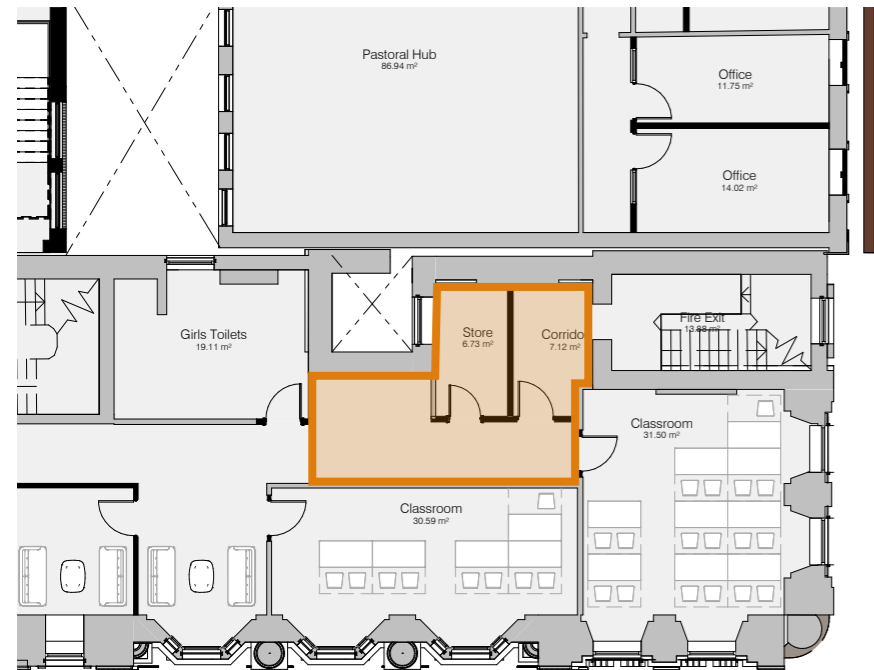
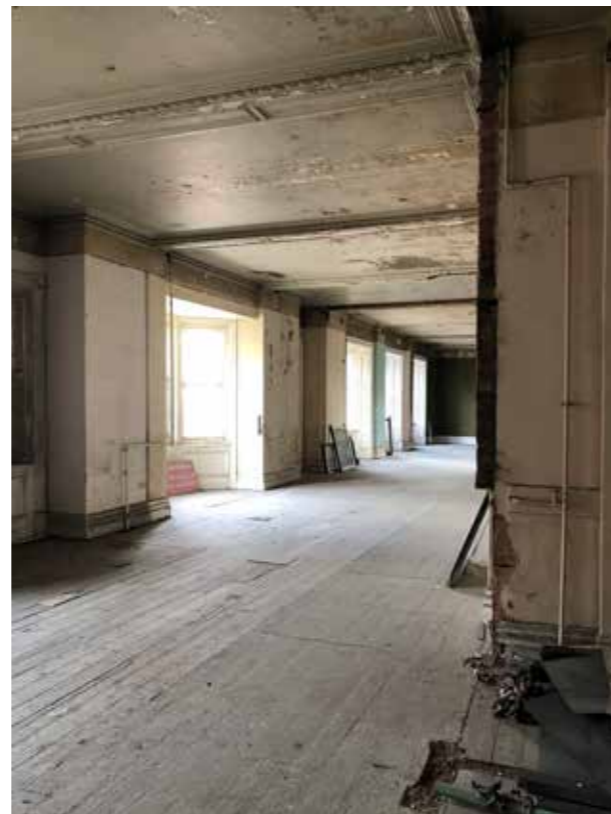
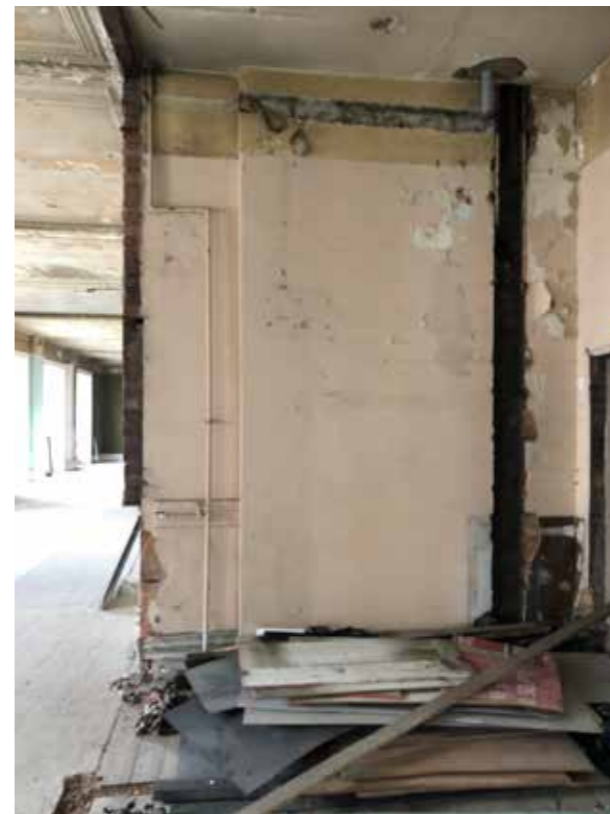
# C1.07

Proposed use: Corridor and Store

- Walls -** Existing plaster walls to be repaired and painted. Areas of poor quality paint to be stripped and made good. All areas to be repainted. Areas of missing plaster to be reinstated. Missing area of wall to be reinstated with timber stud and plasterboard.
- Floors -** Existing concrete floors to be cleaned and overlaid with new timber floor. Existing skirting to be cleaned and painted. Areas of missing skirting to be reinstated with profile to match existing.
- Ceilings -** Holes in ceilings to be repaired and whole ceiling to receive painted finish. Exposed areas of missing cornice to be reinstated, with profile to match existing.
- Doors -** Existing internal doors, frames and architrave to be checked and made good.
- Windows -** Existing windows to be replaced with new slimline double glazed units in timber frames. Windowboards to be made good and painted.

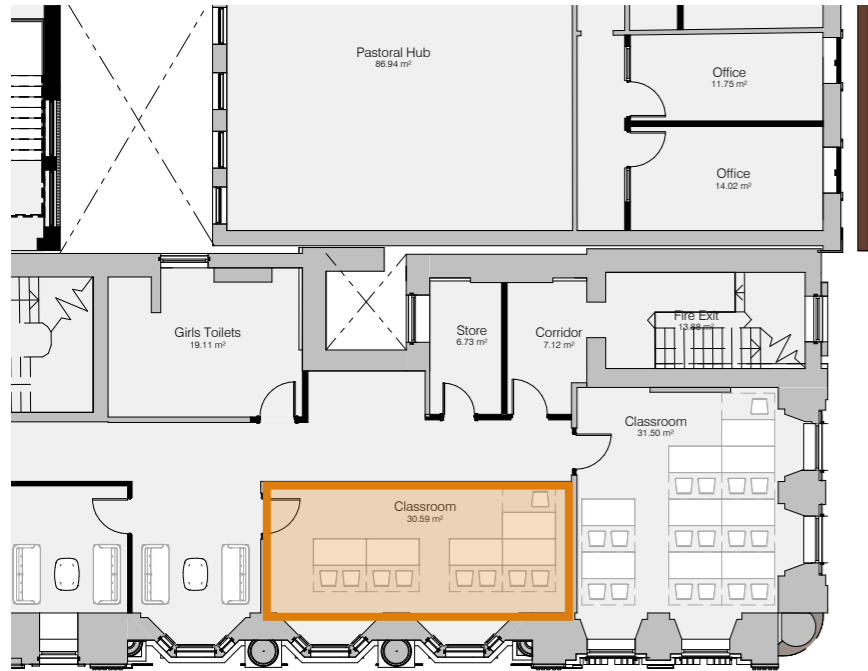
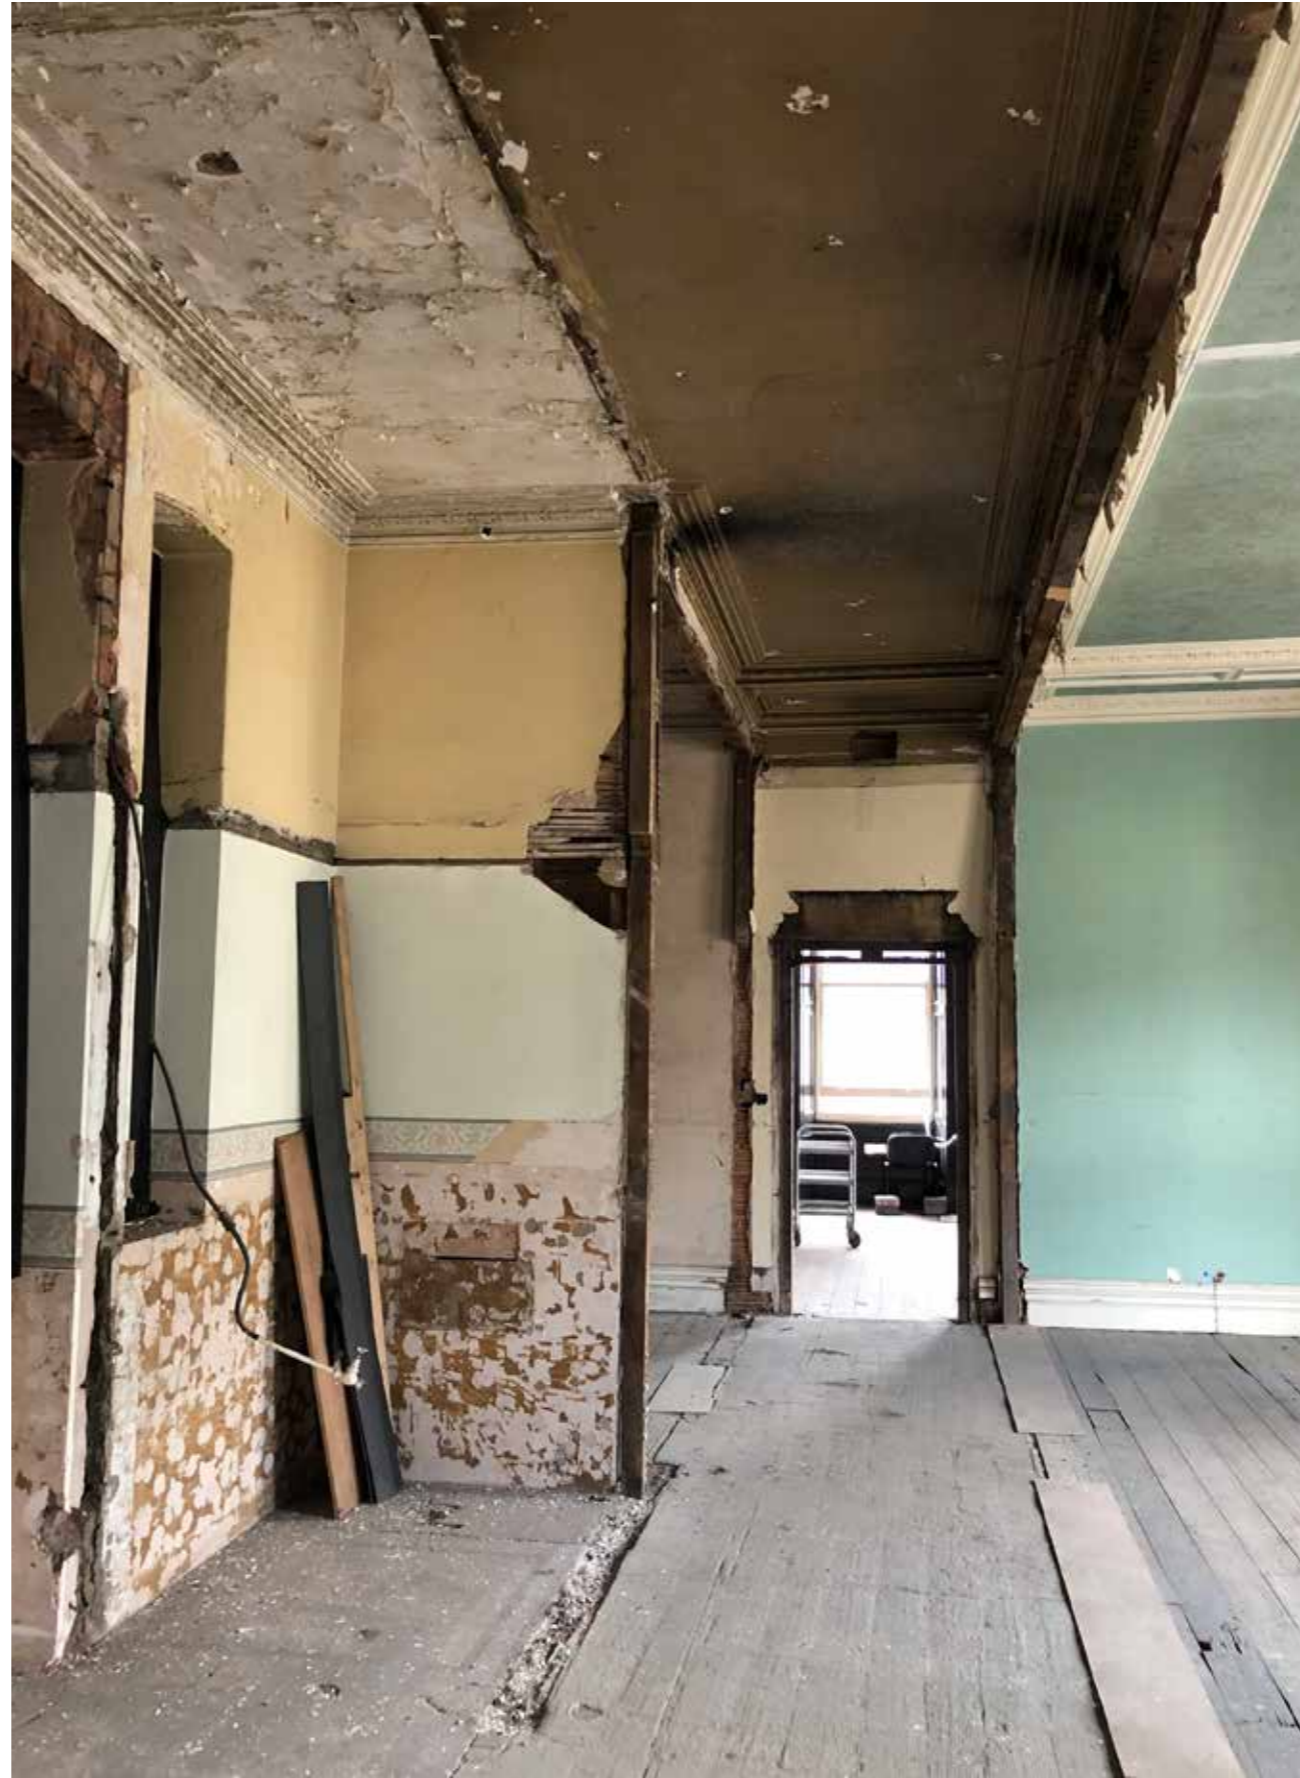
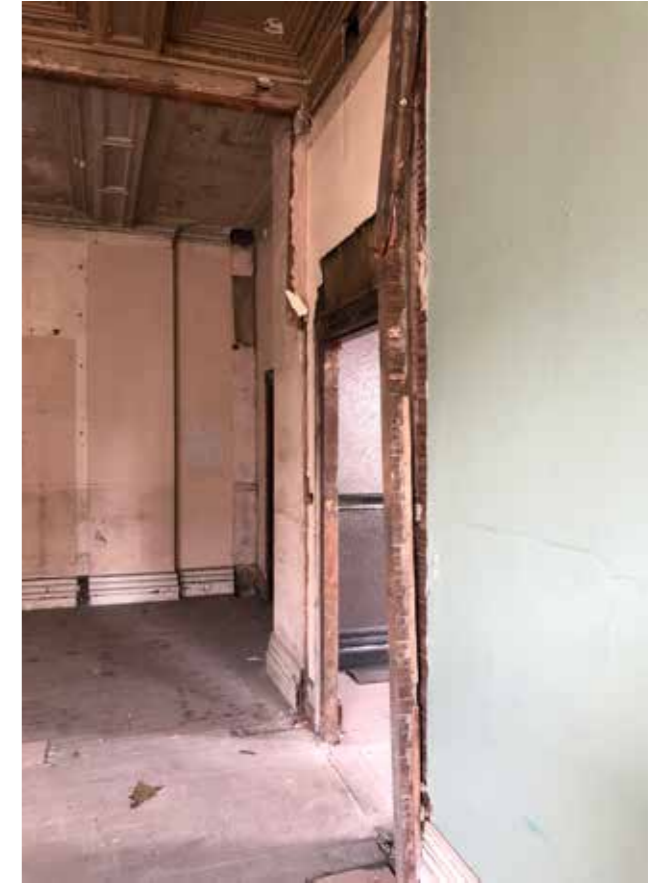
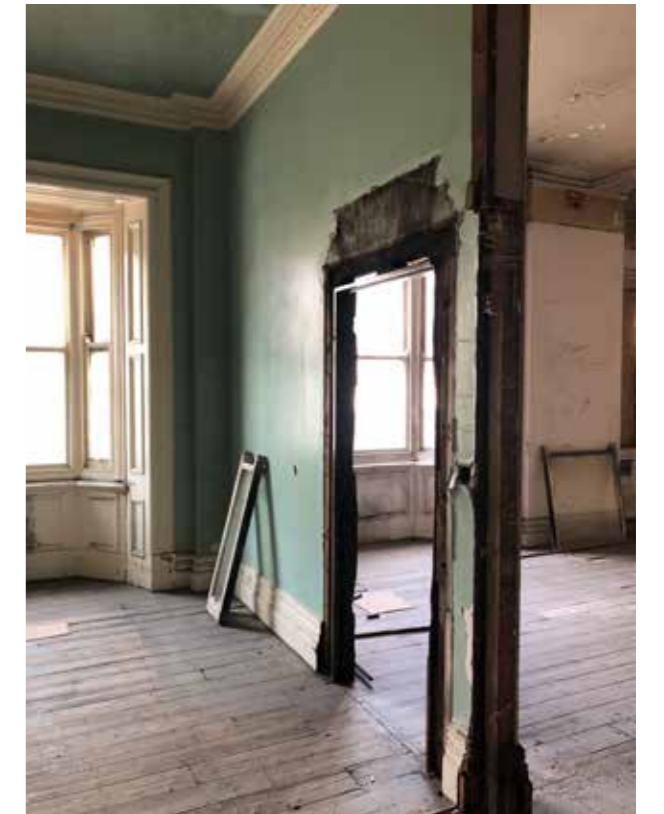
# C1.08

Proposed use: Classroom

- Walls -** Existing plaster walls to be repaired and painted. Areas of poor quality paint to be stripped and made good. All areas to be repainted. Areas of missing plaster to be reinstated. Missing area of wall to be reinstated with timber stud and plasterboard.
- Floors -** Existing concrete floors to be cleaned and overlaid with new timber floor. Existing skirting to be cleaned and painted. Areas of missing skirting to be reinstated with profile to match existing.
- Ceilings -** Holes in ceilings to be repaired and whole ceiling to receive painted finish. Exposed areas of missing cornice to be reinstated, with profile to match existing.
- Doors -** Existing internal doors, frames and architrave to be checked and made good.
- Windows -** None

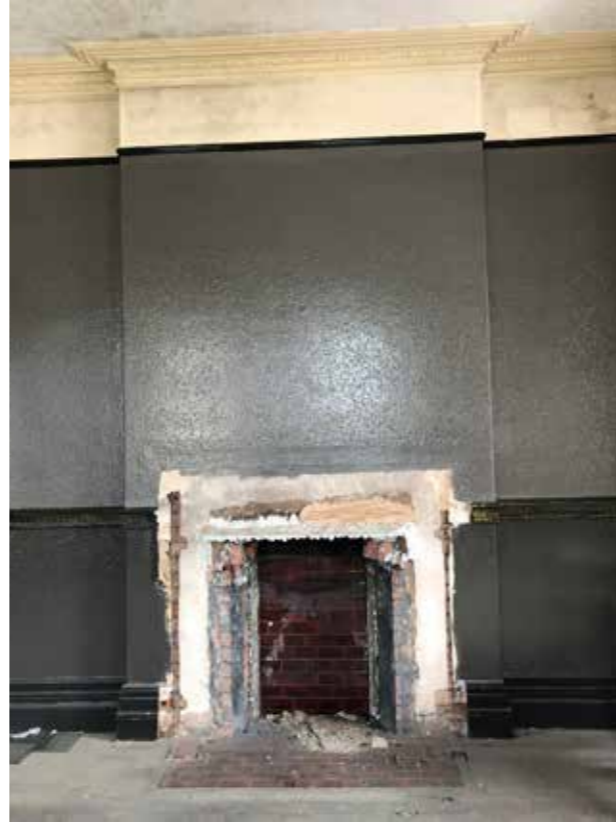
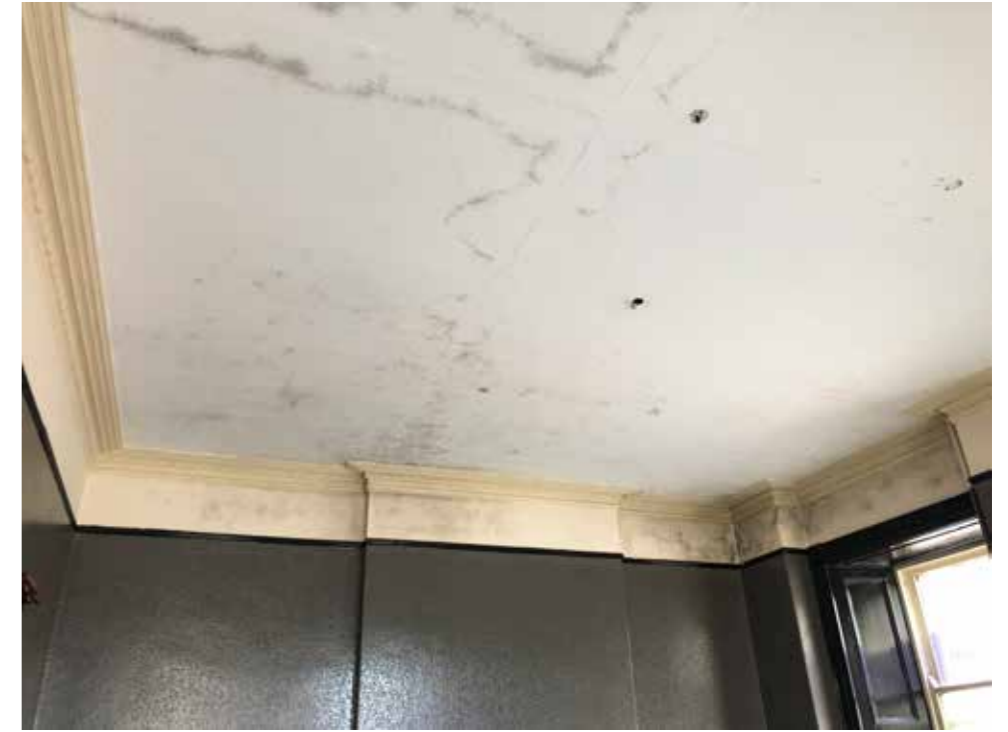
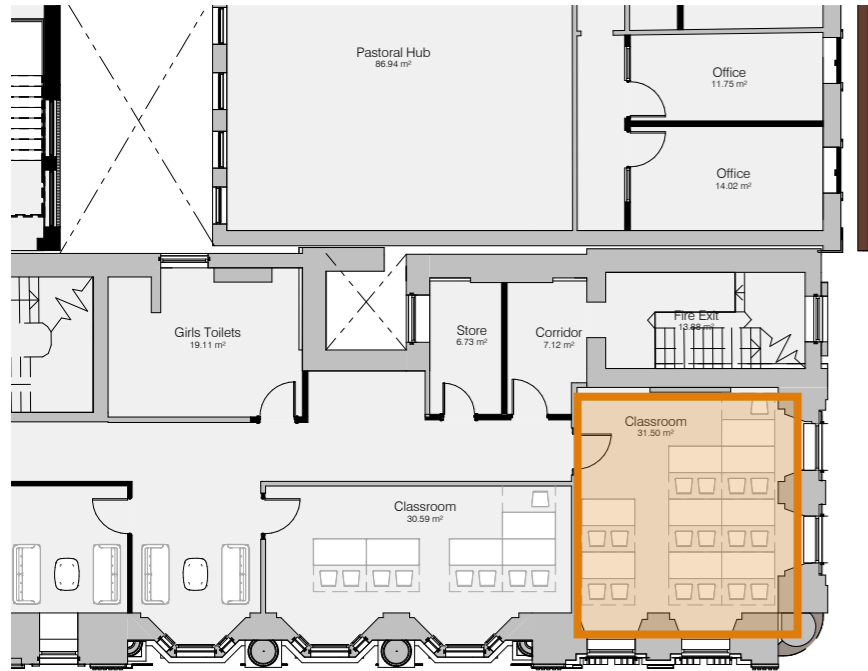
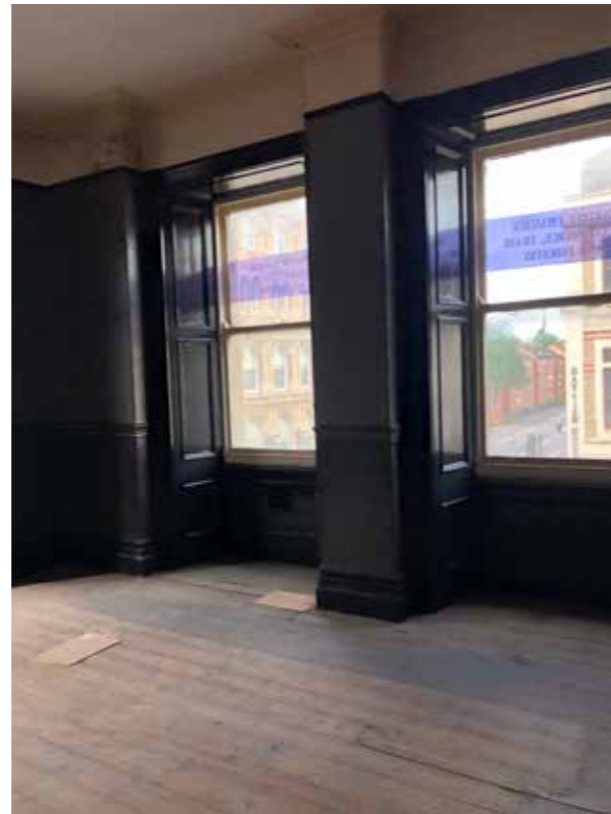
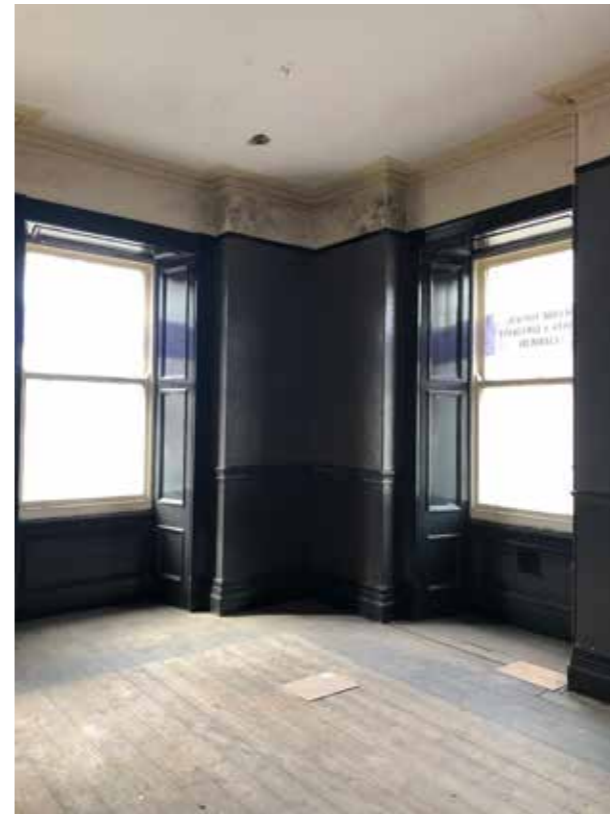
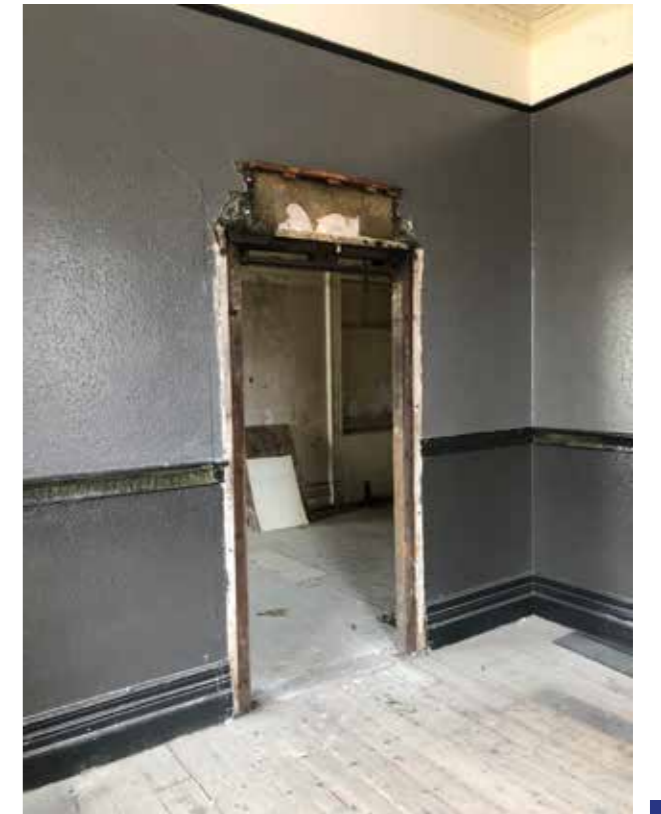
# C1.09

Proposed use: Classroom

- Walls -** Existing plaster walls to be repaired and painted. Areas of poor quality paint to be stripped and made good. All areas to be repainted. Areas of missing plaster to be reinstated. Missing area of wall to be reinstated with timber stud and plasterboard.

- Floors -** Existing concrete floors to be cleaned and overlaid with new timber floor. Existing skirting to be cleaned and painted. Areas of missing skirting to be reinstated with profile to match existing.

- Ceilings -** Holes in ceilings to be repaired and whole ceiling to receive painted finish. Exposed areas of missing cornice to be reinstated, with profile to match existing.

- Doors -** Existing internal doors, frames and architrave to be checked and made good.
- Windows -** Existing windows to be replaced with new slimline double glazed units in timber frames. Windowboards to be made good and painted.

- Other -** Fire place opening to be made good.

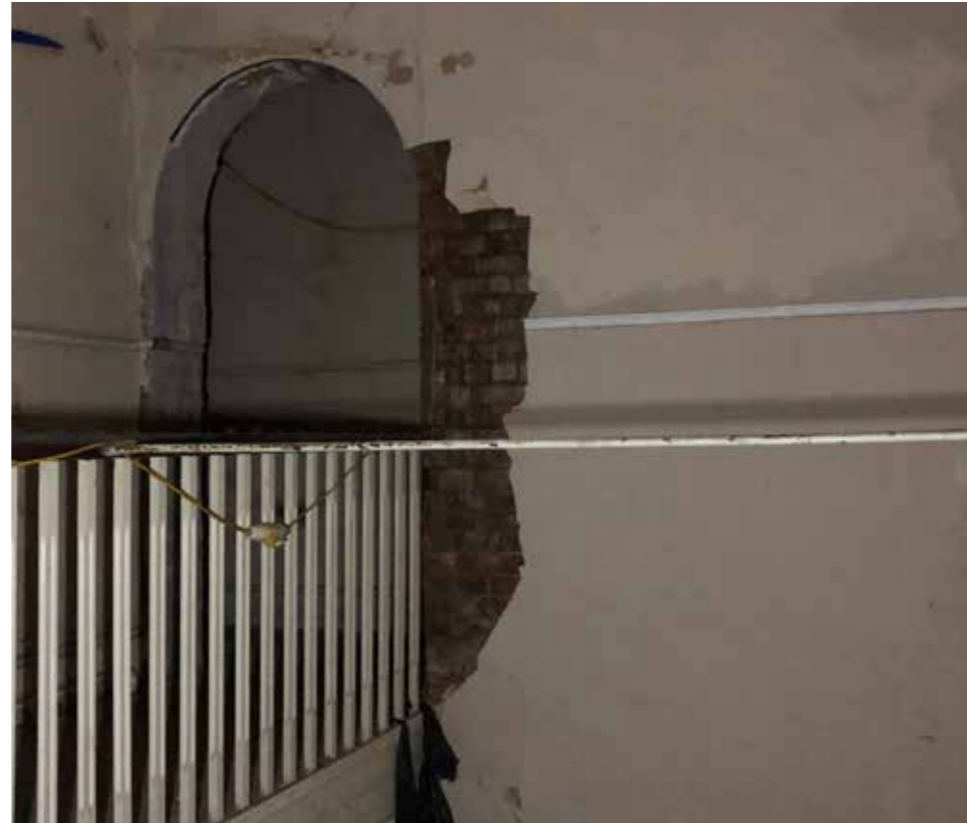
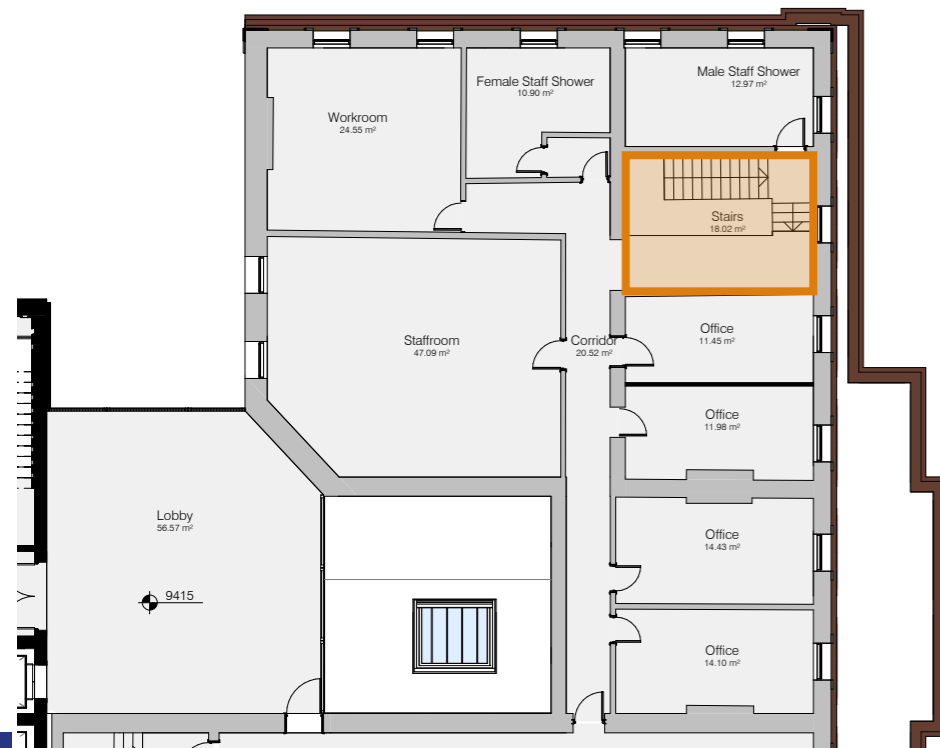
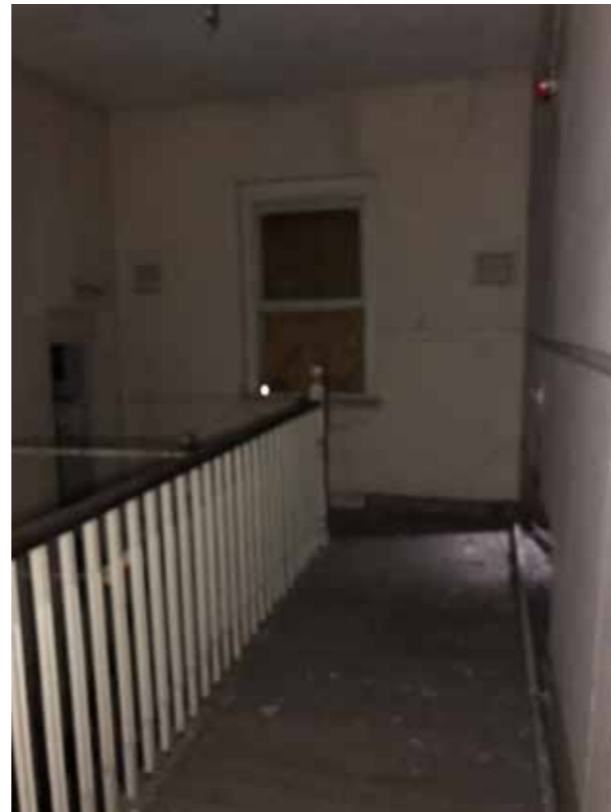
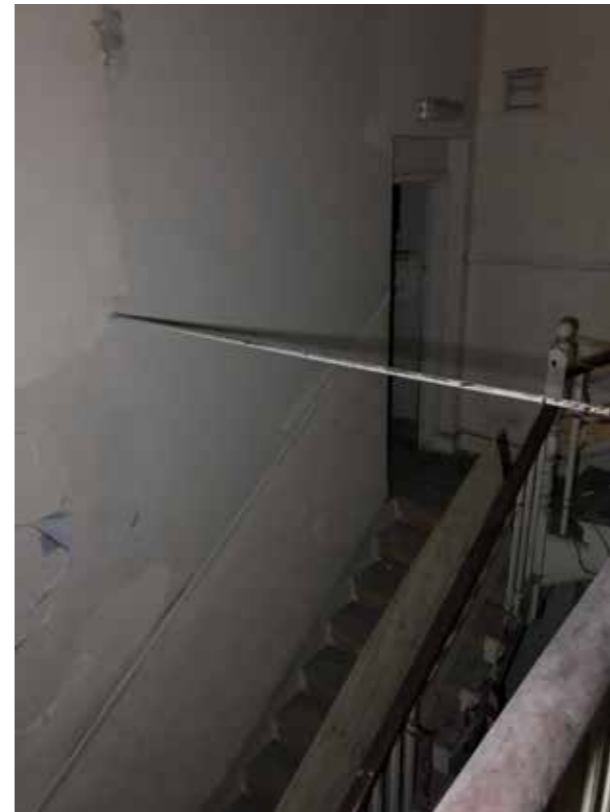
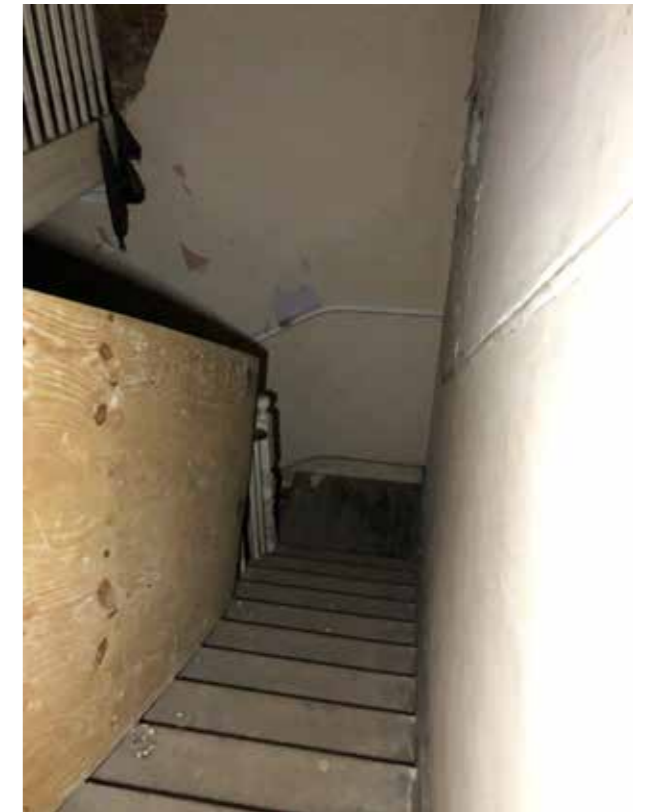
## M2.01

Proposed use: Staff Staircase

- Walls -** Existing plaster to be repaired and painted. Brick walls, existing plaster to be repaired and painted. Areas of missing plaster to have new lime plaster applied and painted.

- Floors -** Existing timber floors to be repaired and overlaid with new carpet finish. Existing skirting to be cleaned and painted. Areas of missing skirting to be reinstated with profile to match existing. Existing skirting to be cleaned and painted. Areas of missing skirting to be reinstated with profile to match existing.

- Ceilings -** Missing ceiling to be reinstated. Timber or metal lath to be fixed to joists and lime plaster applied to be carefully tied into existing retained ceilings. Ceilings to receive painted finish. Missing cornice to be reinstated, with profile to match existing.

- Doors -** Existing doors to be retained and made good.
- Windows -** Existing windows to be replaced with new slimline double glazed units in timber frames.

- Other -** Existing staircase to be cleaned and made good. Underside to be painted. Timber handrail cleaned. Existing balusters to be cleaned and painted, new metal balusters to be fabricated to infill gaps.
