HERITAGE REPAIRS REPORT  
FOR THE REDEVELOPMENT  
OF MERCHANT PLACE AND  
CORY'S BUILDING  
CARDIFF, CF10 5AL

21.22-EDS-XX-ZZ-RP-A-XX-1001  
Heritage Repairs Report  
Revision 02

Applicant:  
Dukes Education

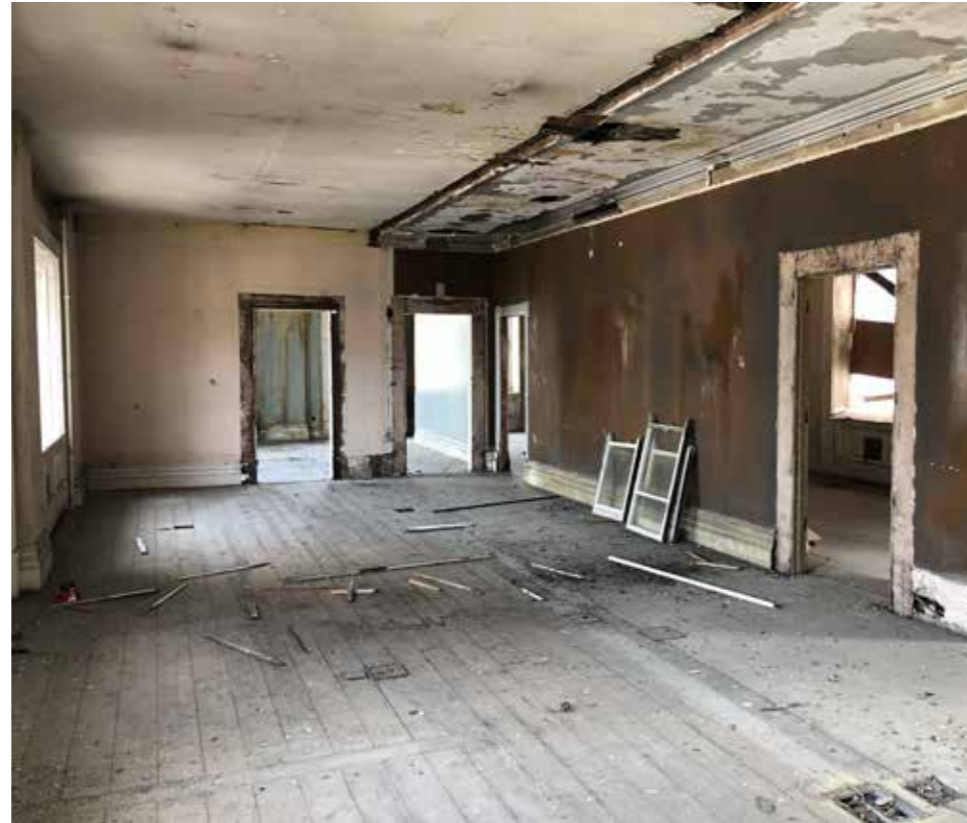
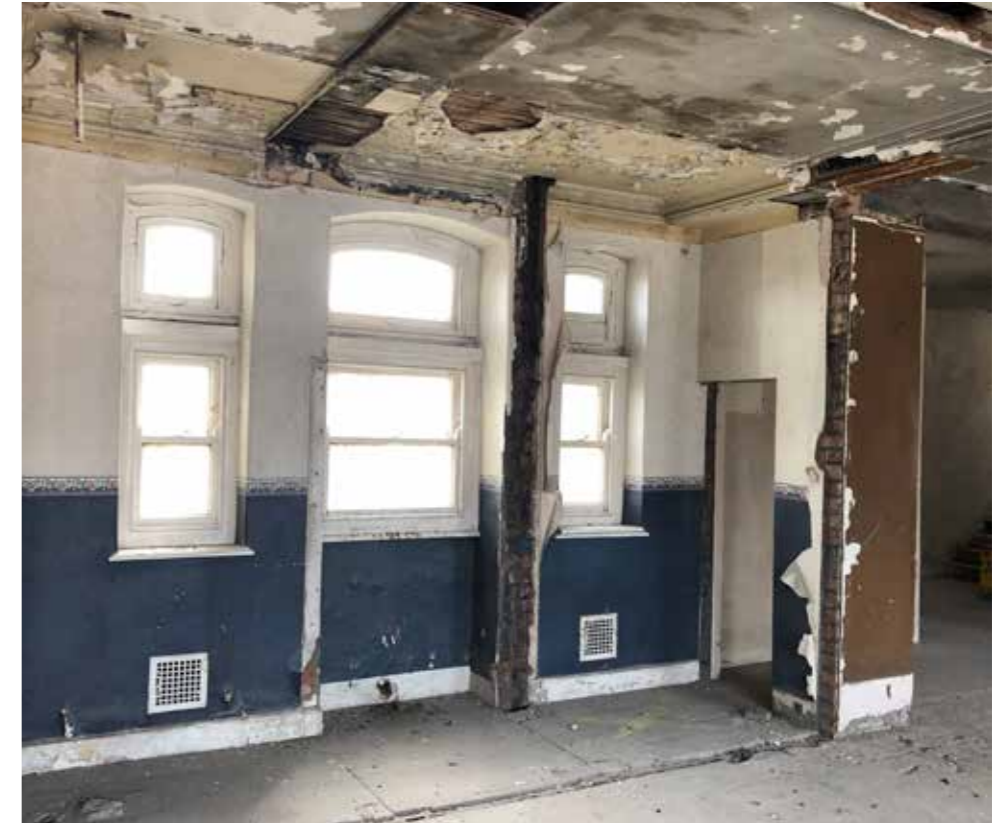
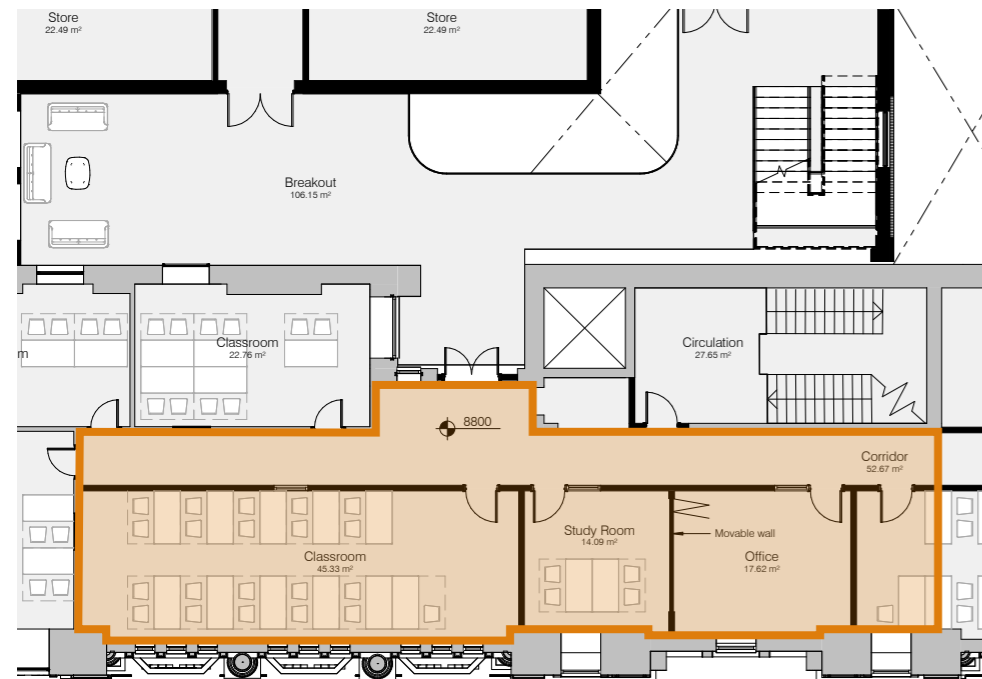
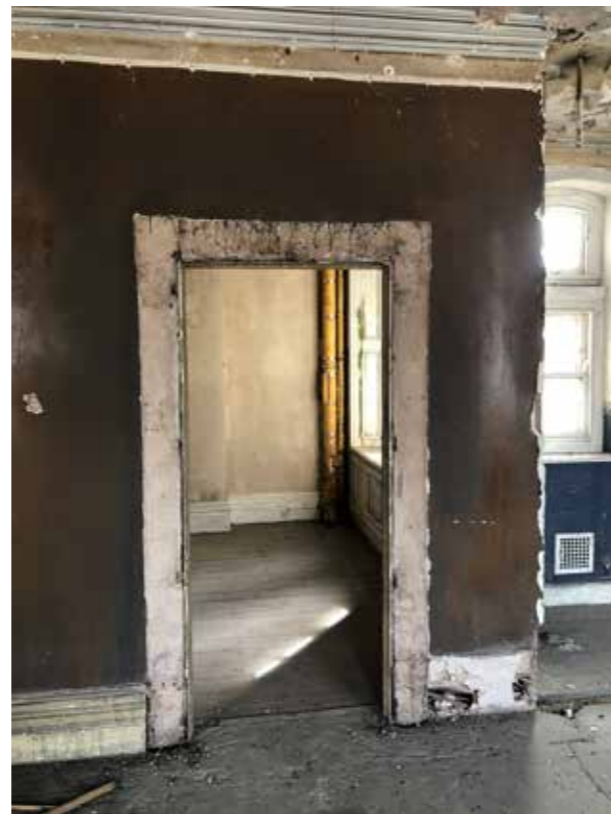
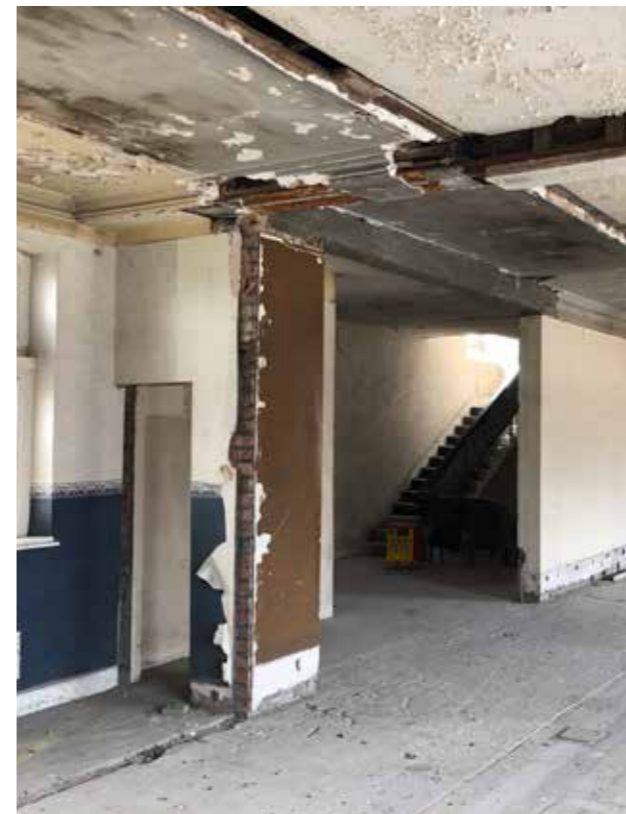
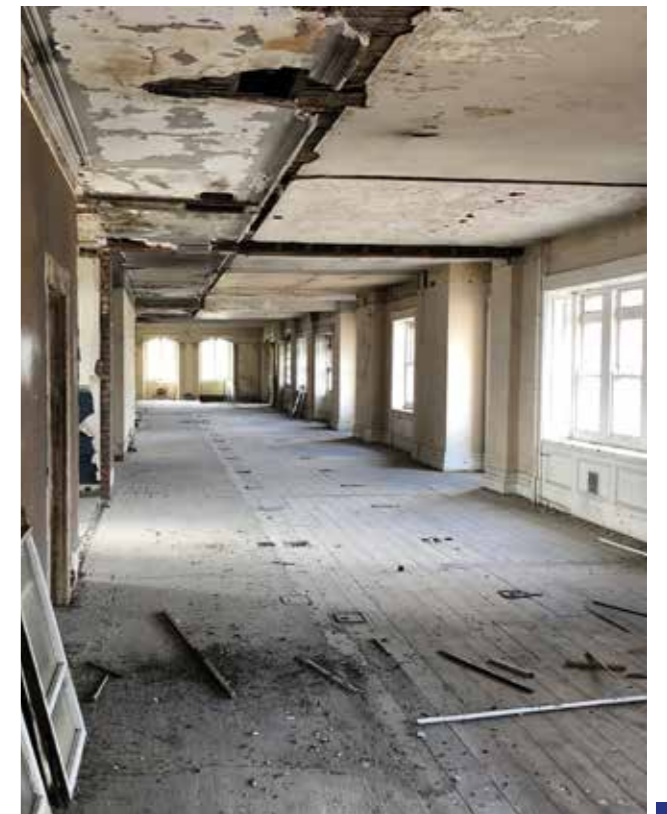
# C2.01A

Proposed use: Classroom, study room, corridor and office

- Walls -** Existing plaster walls to be repaired and painted. Areas of poor quality paint to be stripped and made good. All areas to be repainted. Areas of missing plaster to be reinstated.
- Floors -** Existing concrete floors to be cleaned and overlaid with new timber floor. Existing skirting to be cleaned and painted. Areas of missing skirting to be reinstated with profile to match existing.
- Ceilings -** Holes in ceilings to be repaired and whole ceiling to receive painted finish. Exposed areas of missing cornice to be reinstated, with profile to match existing.
- Doors -** Existing internal doors, frames and architrave to be checked and made good.
- Windows -** Existing windows to be replaced with new slimline double glazed units in timber frames. Windowboards to be made good and painted.

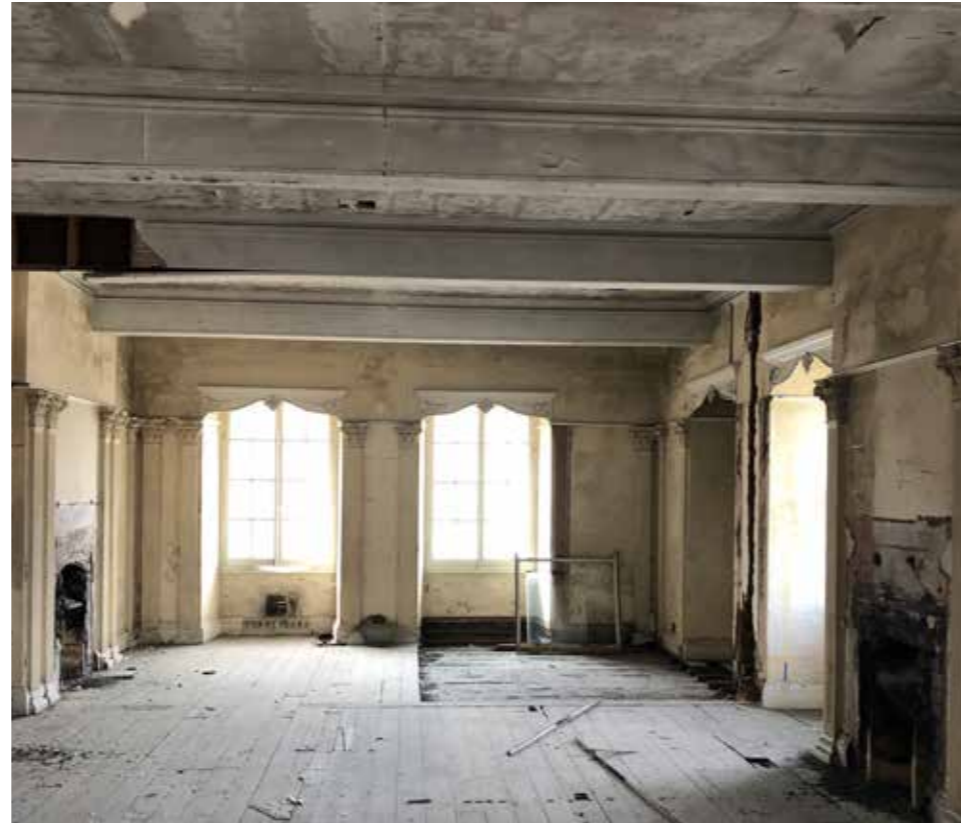
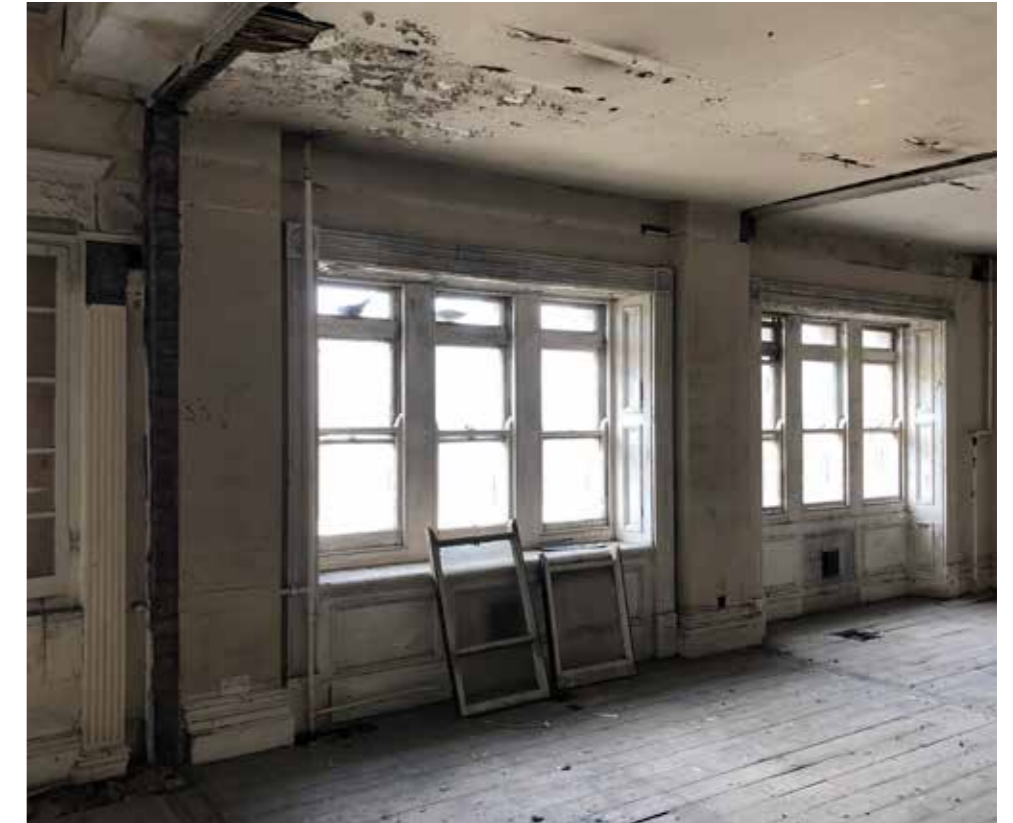
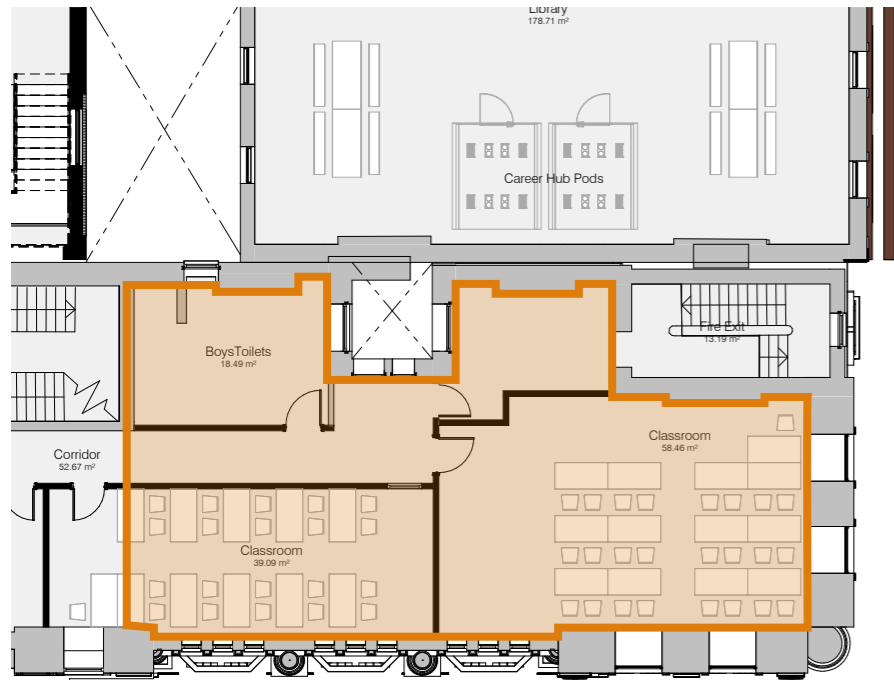
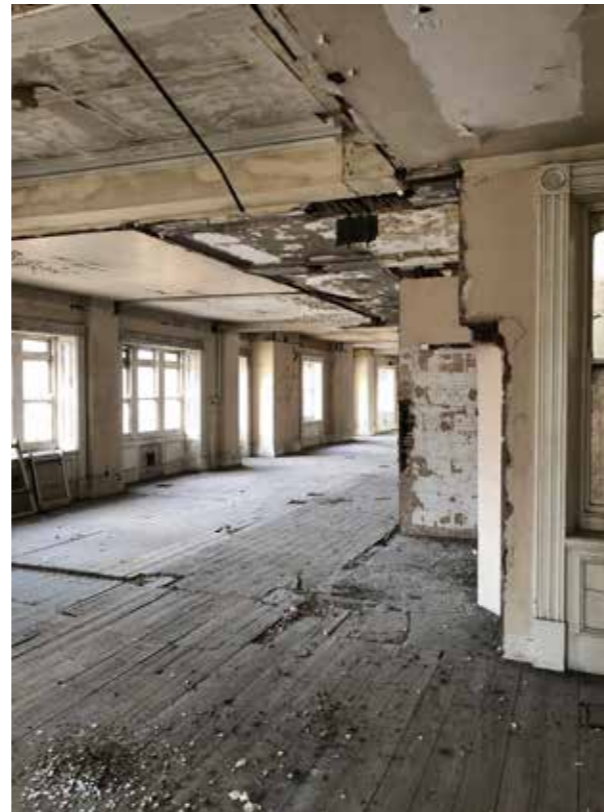
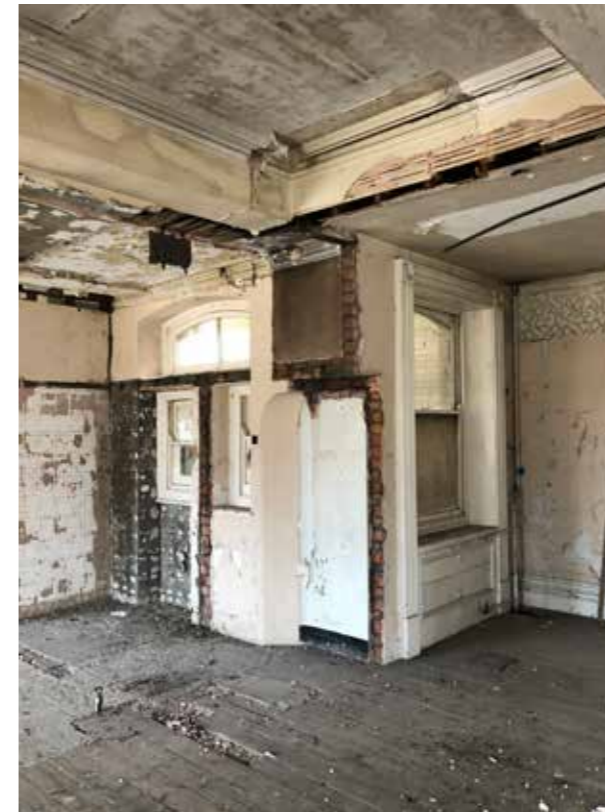
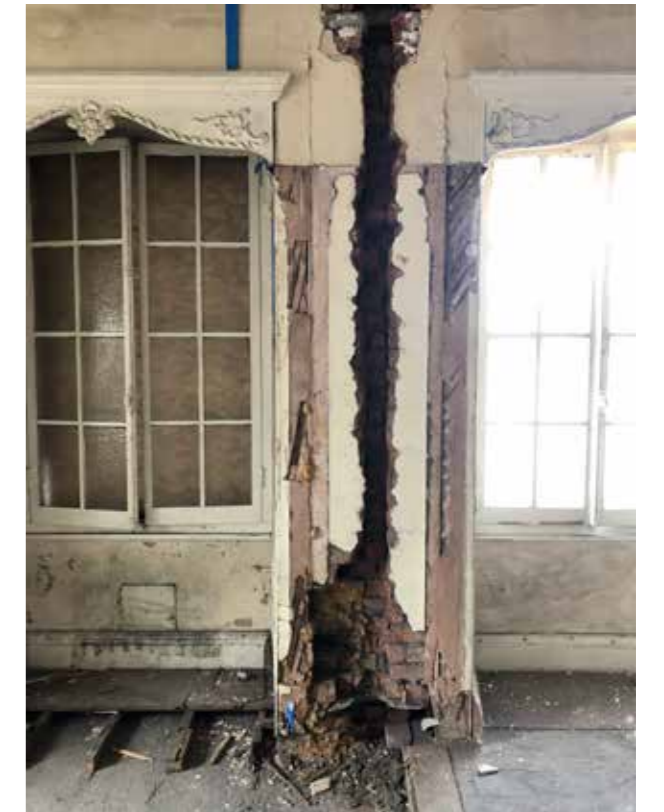
## C2.01B

Proposed use: Classroom, boys toilet and corridor

- Walls -** Existing plaster walls to be repaired and painted. Areas of poor quality paint to be stripped and made good. All areas to be repainted. Areas of missing plaster to be reinstated.
- Floors -** Existing concrete floors to be cleaned and overlaid with new timber floor. Existing skirting to be cleaned and painted. Areas of missing skirting to be reinstated with profile to match existing.
- Ceilings -** Holes in ceilings to be repaired and whole ceiling to receive painted finish. Exposed areas of missing cornice to be reinstated, with profile to match existing.
- Doors -** Existing internal doors, frames and architrave to be checked and made good.
- Windows -** Existing windows to be replaced with new slimline double glazed units in timber frames. Windowboards to be made good and painted.

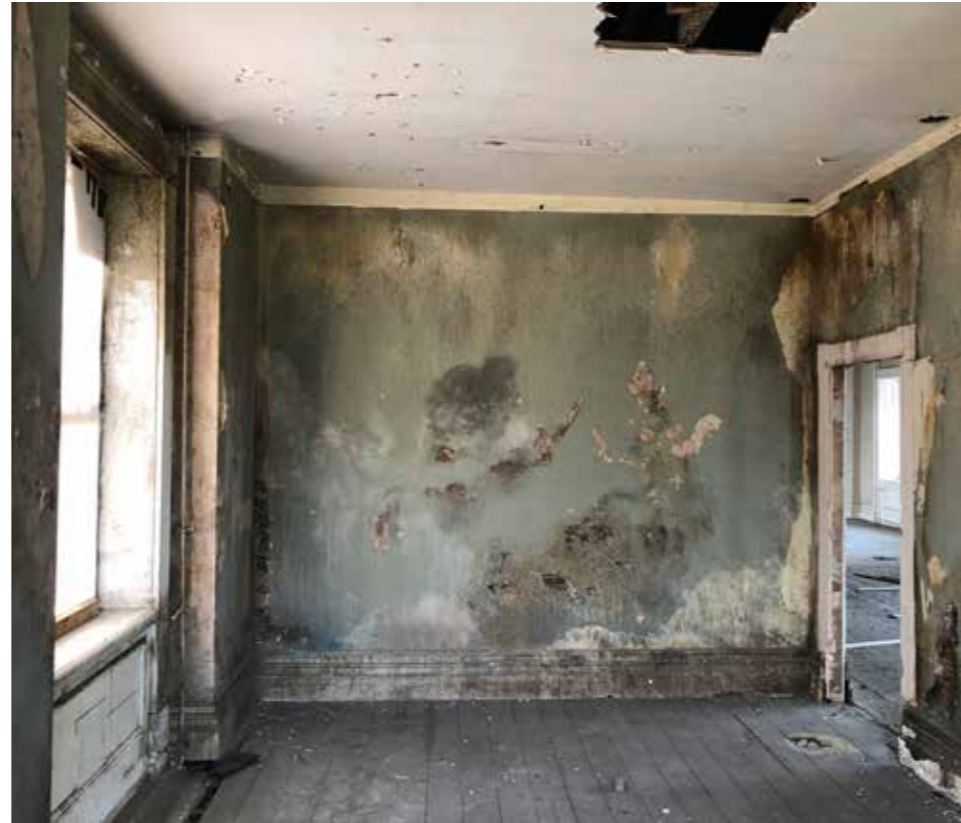
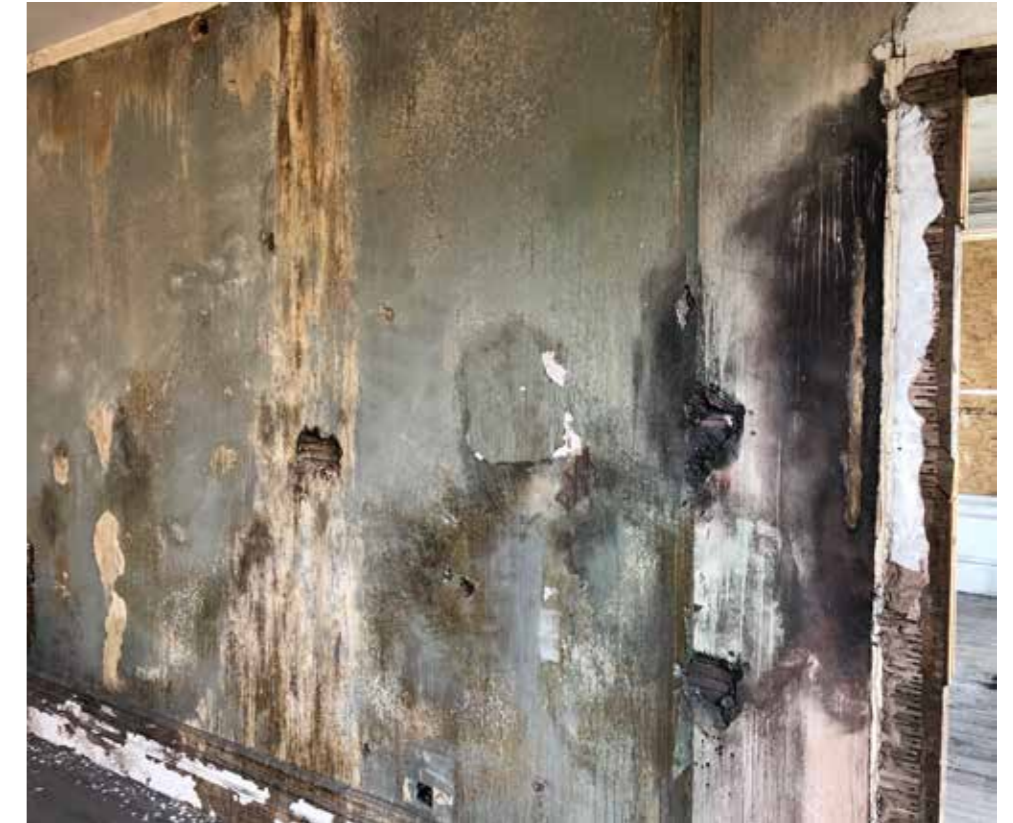
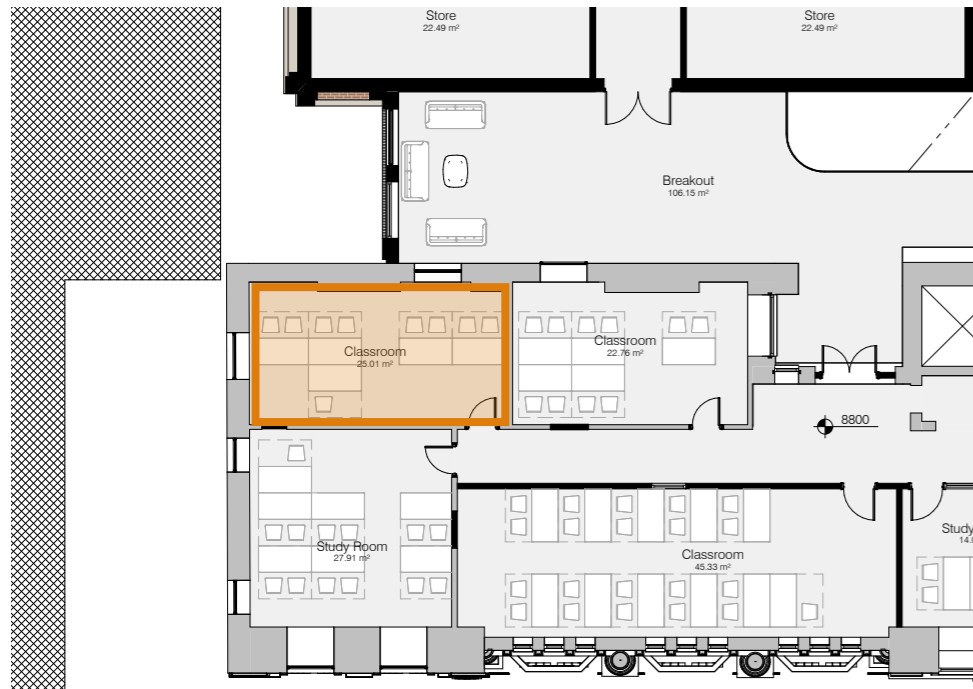
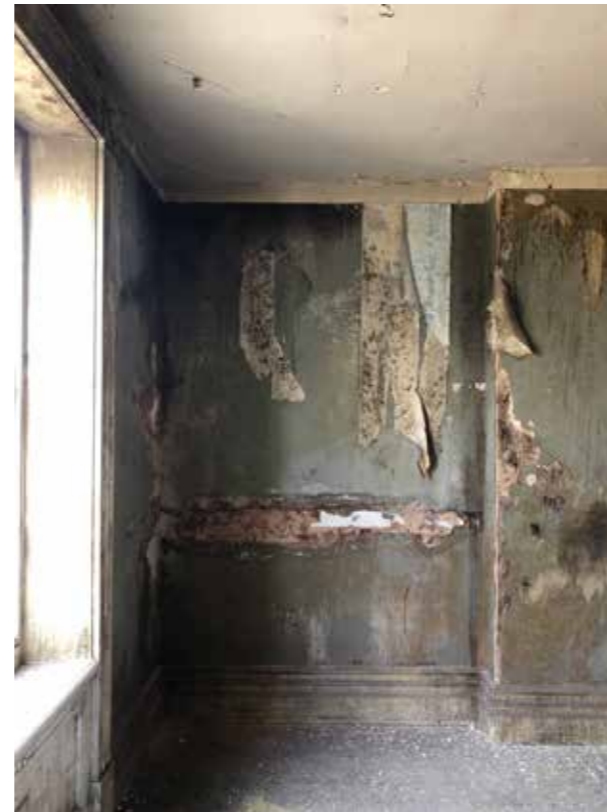
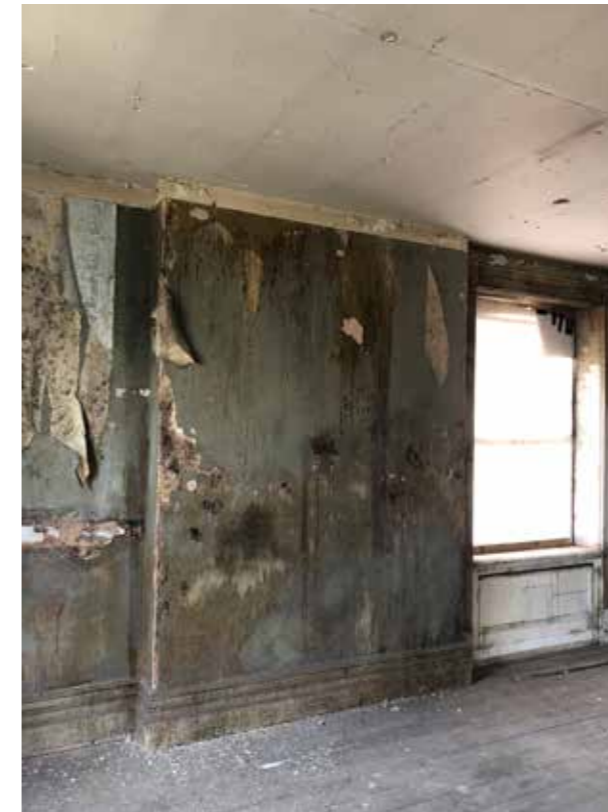
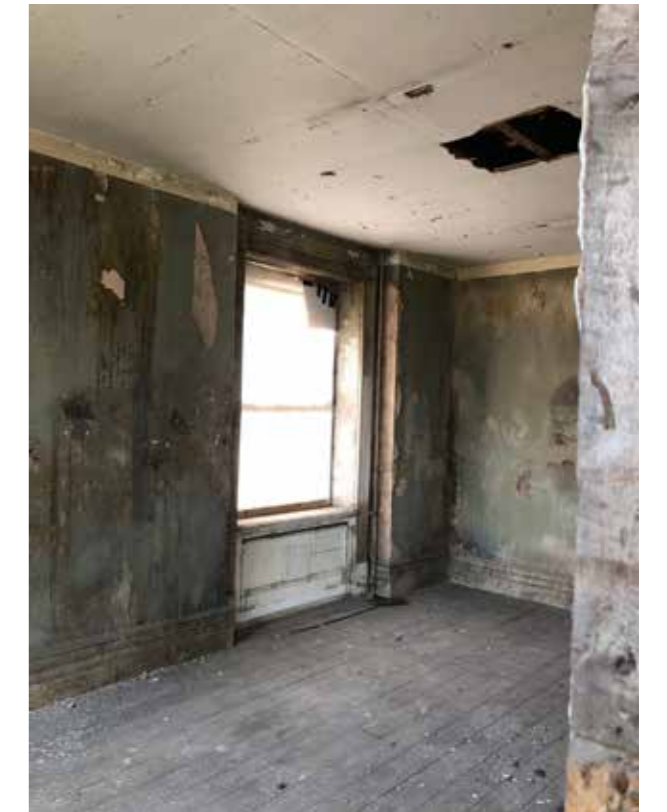
## C2.03

Proposed use: Classroom

- Walls -** Existing plaster walls to be repaired and painted. Areas of poor quality paint to be stripped and made good. All areas to be repainted. Areas of missing plaster to be reinstated. Missing area of wall to be reinstated with timber stud and plasterboard.

- Floors -** Existing concrete floors to be cleaned and overlaid with new timber floor. Existing skirting to be cleaned and painted. Areas of missing skirting to be reinstated with profile to match existing.

- Ceilings -** Holes in ceilings to be repaired and whole ceiling to receive painted finish. Exposed areas of missing cornice to be reinstated, with profile to match existing.

- Doors -** Existing internal doors, frames and architrave to be checked and made good.
- Windows -** Existing windows to be replaced with new slimline double glazed units in timber frames. Windowboards to be made good and painted.

- Other -** Fire place opening to be made good.

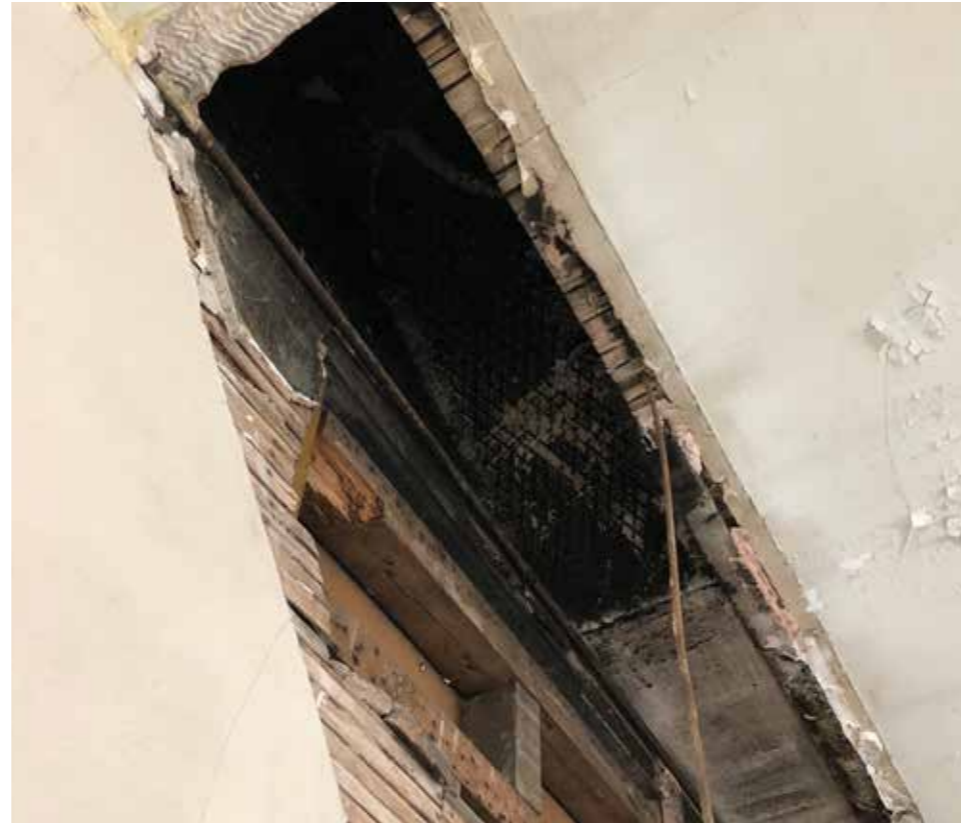
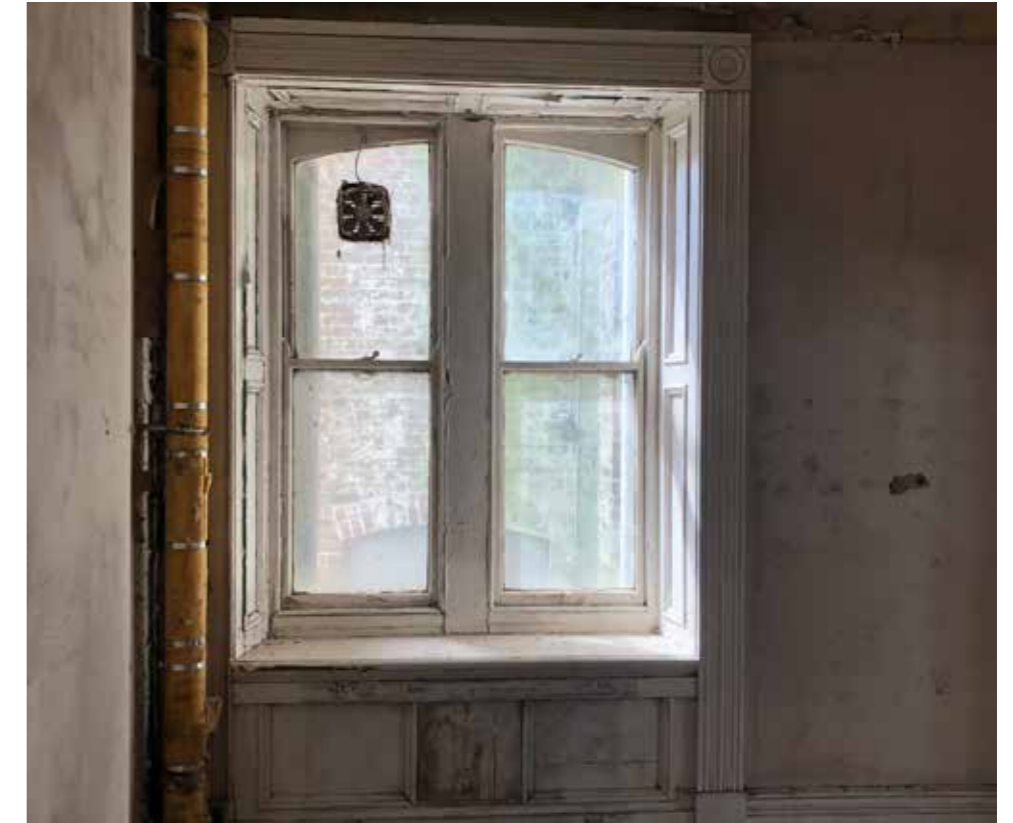
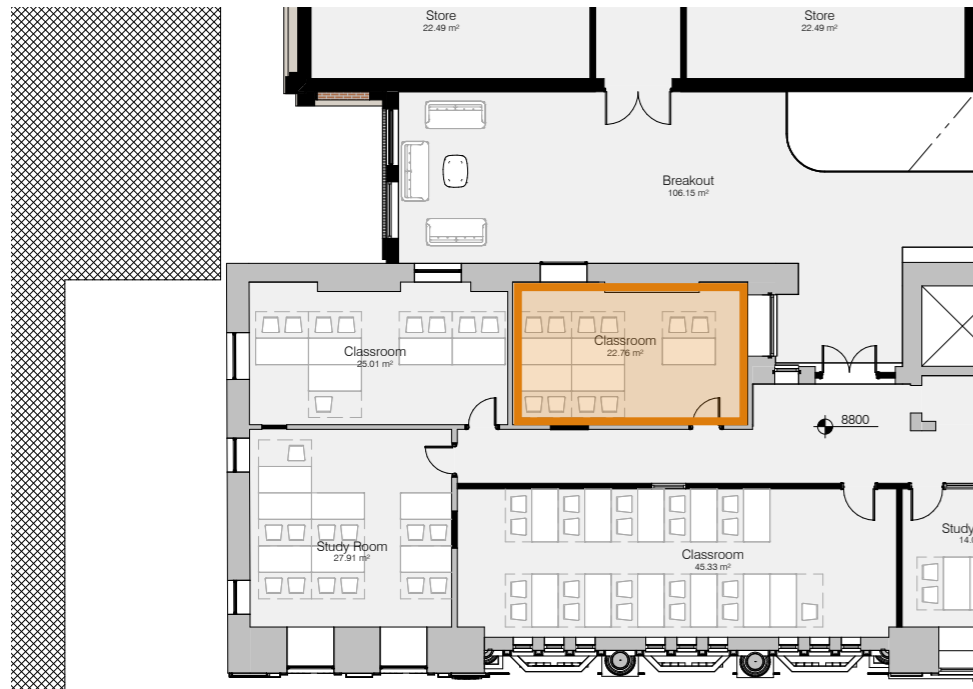
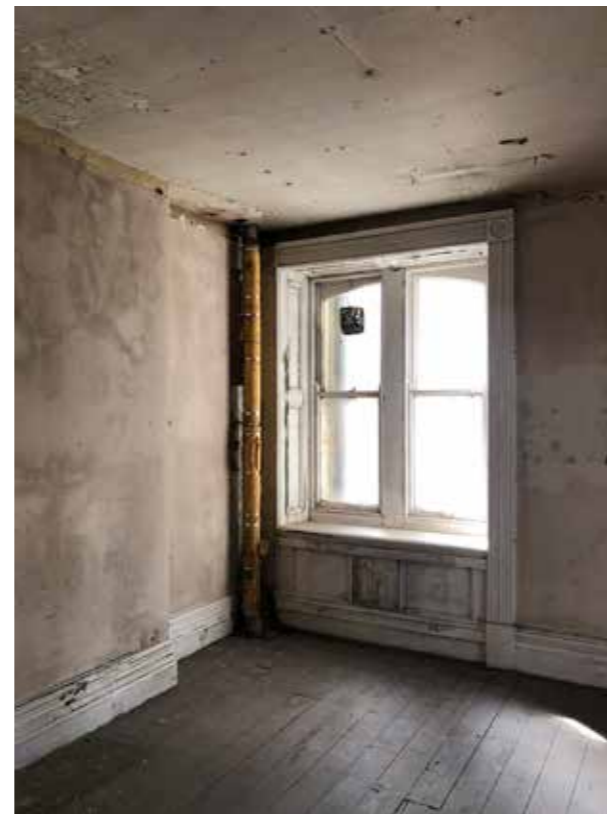
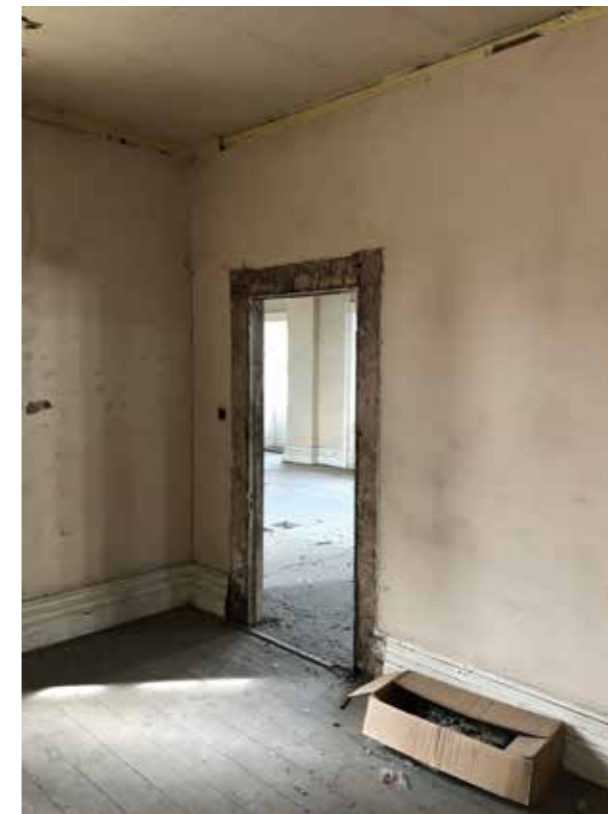
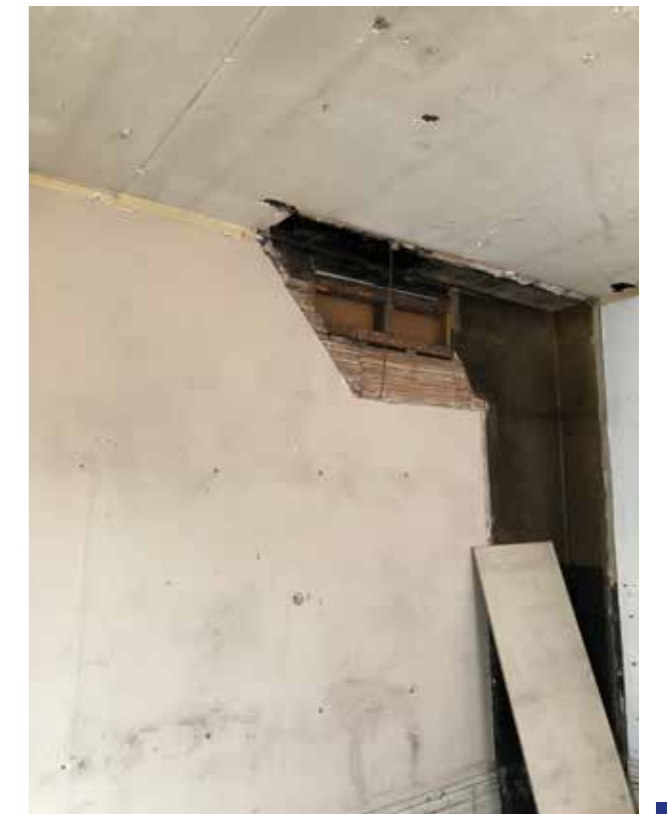
## C2.04

Proposed use: Study Room

- Walls -** Existing plaster walls to be repaired and painted. Areas of poor quality paint to be stripped and made good. All areas to be repainted. Areas of missing plaster to be reinstated. Missing area of wall to be reinstated with timber stud and plasterboard.

- Floors -** Existing concrete floors to be cleaned and overlaid with new timber floor. Existing skirting to be cleaned and painted. Areas of missing skirting to be reinstated with profile to match existing.

- Ceilings -** Holes in ceilings to be repaired and whole ceiling to receive painted finish. Exposed areas of missing cornice to be reinstated, with profile to match existing.

- Doors -** Existing internal doors, frames and architrave to be checked and made good.
- Windows -** Existing windows to be replaced with new slimline double glazed units in timber frames. Windowboards to be made good and painted.

- Other -** Fire place opening to be made good.

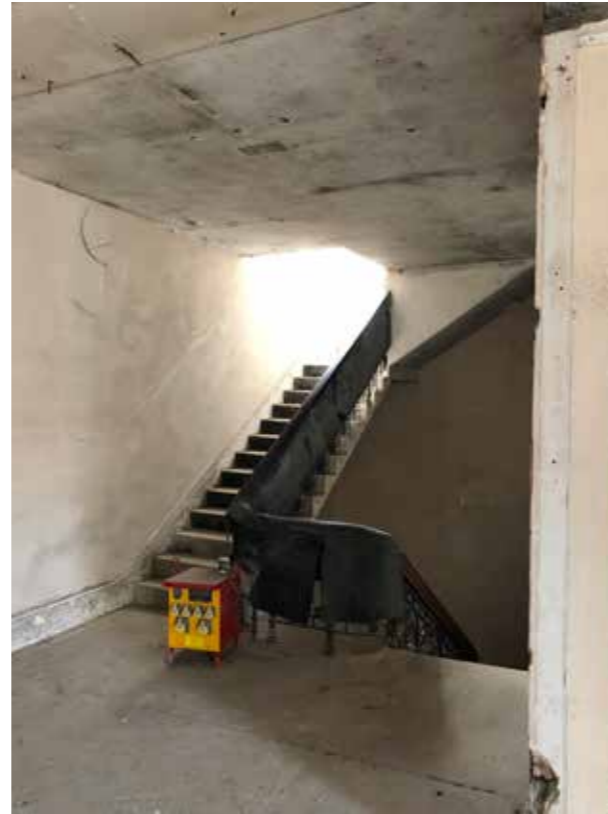
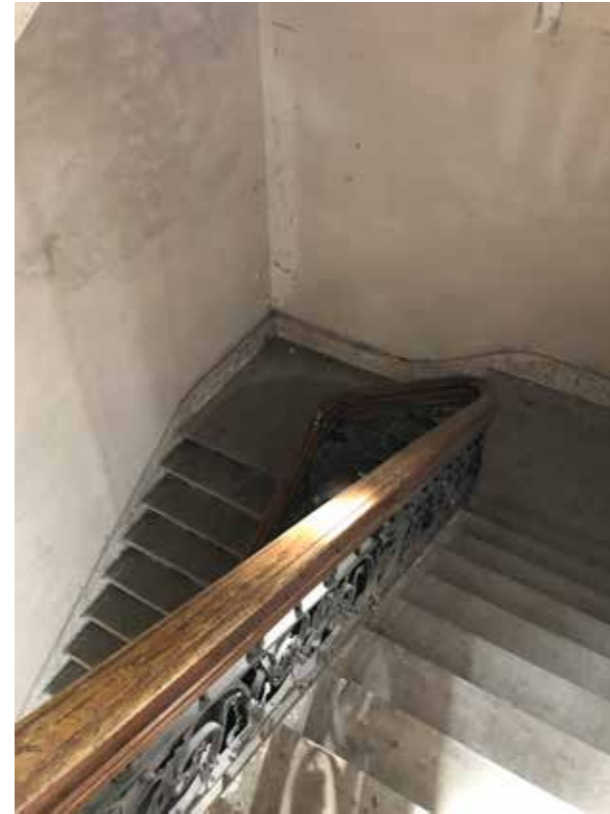
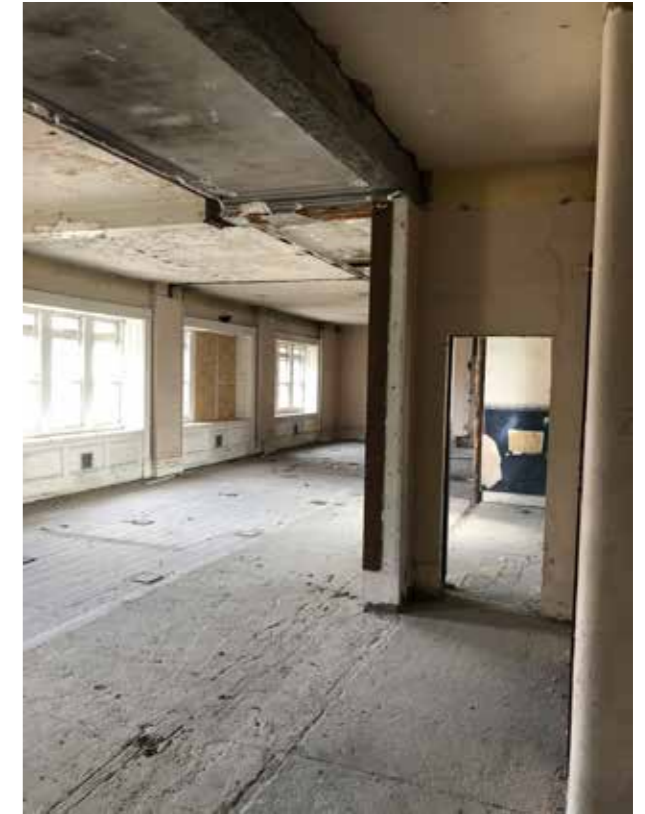
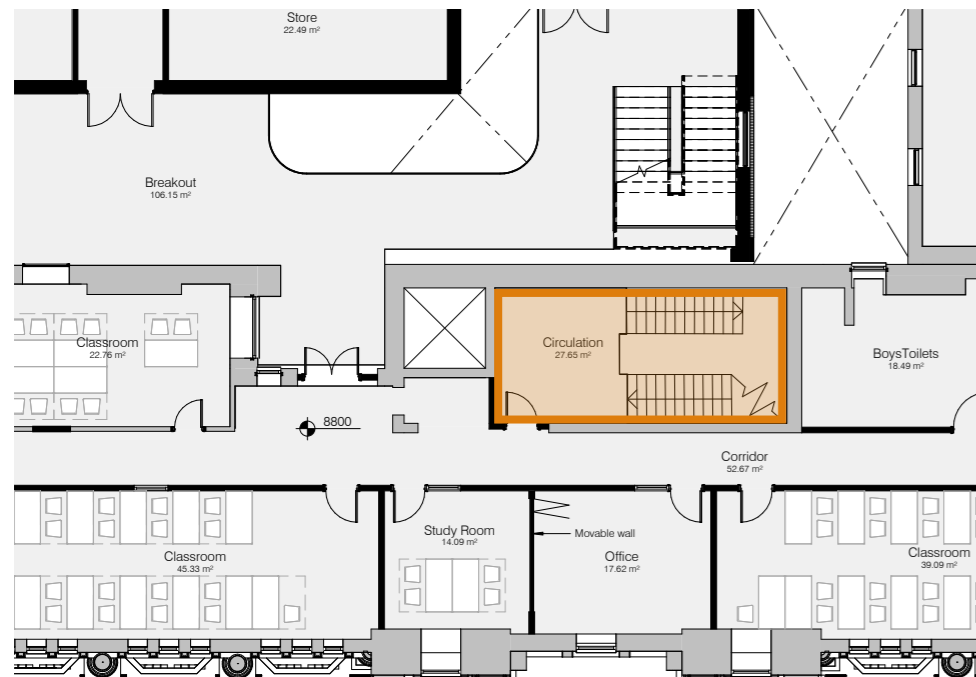
## C2.05

Proposed use: Stairs

- Walls -** Existing plaster walls to be repaired and painted. Areas of poor quality paint to be stripped and made good. All areas to be repainted. Areas of missing plaster to be reinstated.
- Floors -** Existing concrete floors to be cleaned and retained. Existing skirting to be cleaned and painted. Areas of missing skirting to be reinstated with profile to match existing.
- Ceilings -** Underside of stairs to be cleaned and painted.
- Doors -** No existing doors present.
- Windows -** Existing windows to be replaced with new slimline double glazed units in timber frames. Windowboards to be made good and painted.
- Other -** Handrail to be cleaned and painted. Height of handrail to be increased to ensure compliance with modern Building Regulations.
